LABORATORY EXPERIMENTS ON EROSION CONTROL PERFORMANCE OF AN L-SHAPED PERMEABLE STRUCTURE

Yuuji Maeda¹, Masayuki Unno², Masafumi Sato², Takao Kurita², Takaaki Uda³ and Shinji Sato⁴

A new type of structure will be constructed on the Shimizu coast for erosion control. The structure is L-shaped permeable structure; a shore-parallel permeable detached breakwater supported by steel piles and a shore-normal rubble mound jetty covered by flat concrete blocks. This study aims to examine the erosion control performance of the new type of structure through movable-bed experiments. Significant entrapment of sand behind shore-parallel breakwaters was observed despite larger wave transmission due to permeable structure. The erosion control performance of the structure was found insensitive to the gap between the shore-normal jetty and the shore-parallel breakwater. Supplementary nourishment was found effective to mitigate the downdrift erosion and accelerate the entrapment of sand behind the shore-parallel breakwater.

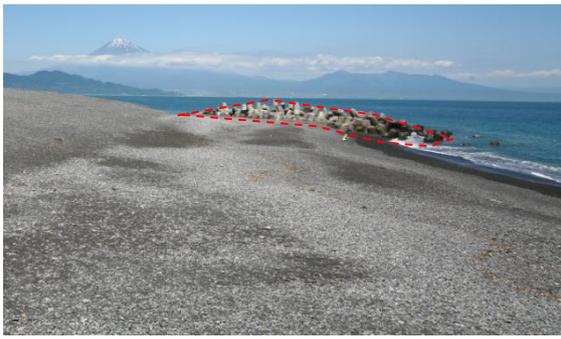
Figure 28. Current landscape.

Figure 28 shows current landscape of the Shimizu coast and Figure 29 shows composite photograph using 3D model of the L-shaped structure and experimental result in Case 4. The landscape will be improved because the visible area of structure as indicated by a red line in Figure 29 is smaller than that in Figure 28.
