# COASTAL DYNAMICS 2017

## Field Excursion Northern Zealand Beaches

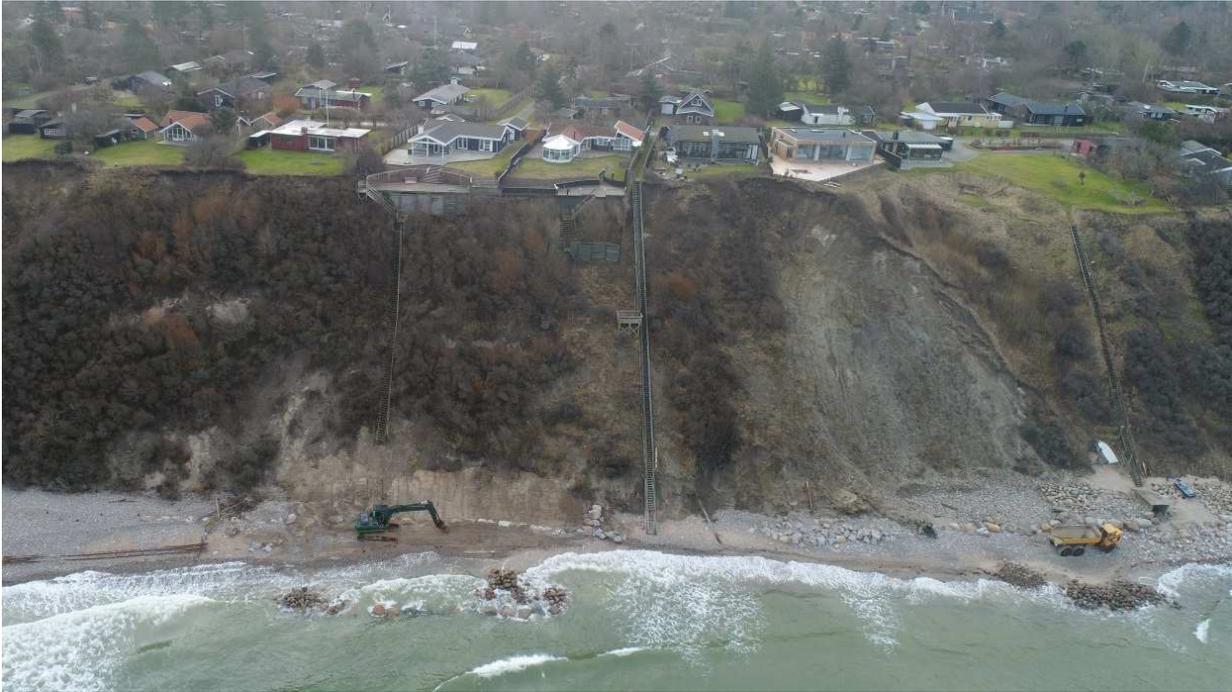
Figure 3 Houses and slides along a steep coastal cliff with moraine clays

Moraine clay is especially present in coastal cliffs at the central part of the coast. These steep cliffs often have slumps and slides. These slides are caused by geotechnical instability and are triggered by groundwater flow, and wave erosion of the toe of the cliff.

Many houses are located on top of these instable cliffs. For some it is a problem, for some it isn't. The views are great, but the erosion may threaten the existence of the houses. Figure 3 shows a newly build house just above a fresh landslide.

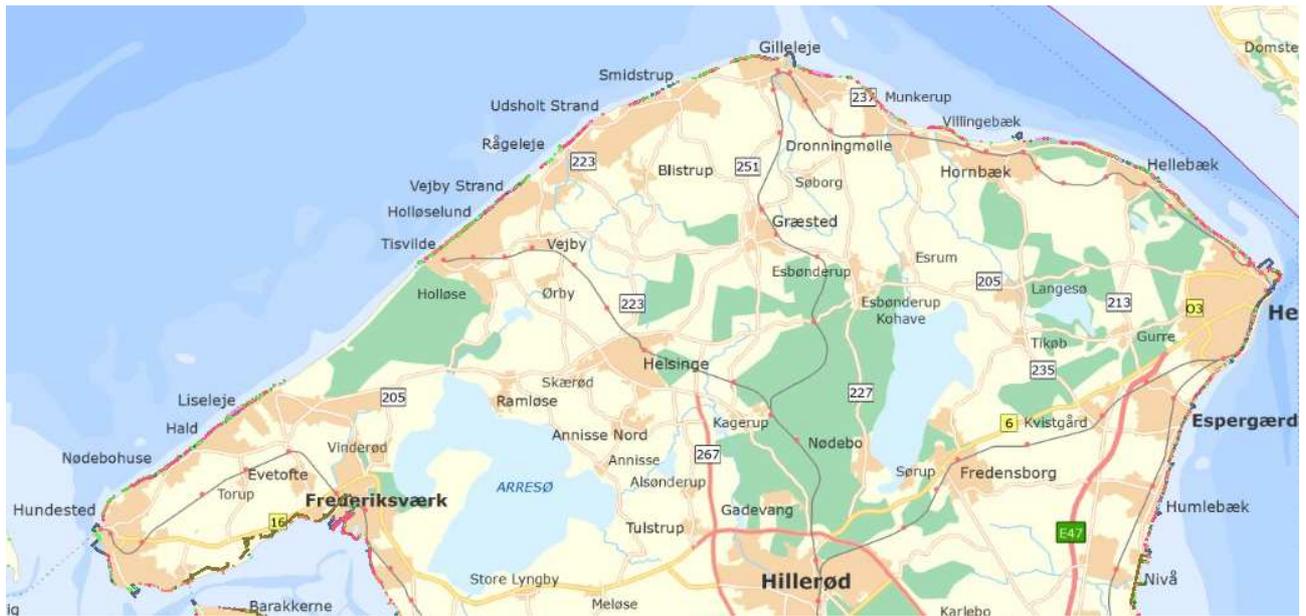
- Construction
- Bypass
- Sand nourishment
- Offshore breakwater
- Groin
- Revetment
- Breakwater
- Dike

Figure 10 Coastal protection

The coast of northern Zealand is one of the most densely protected coastal stretches in Denmark. It is intensively protected by many kinds of passive, hard structures (Figure 10). There is a long tradition of these hard coastal protection structures.

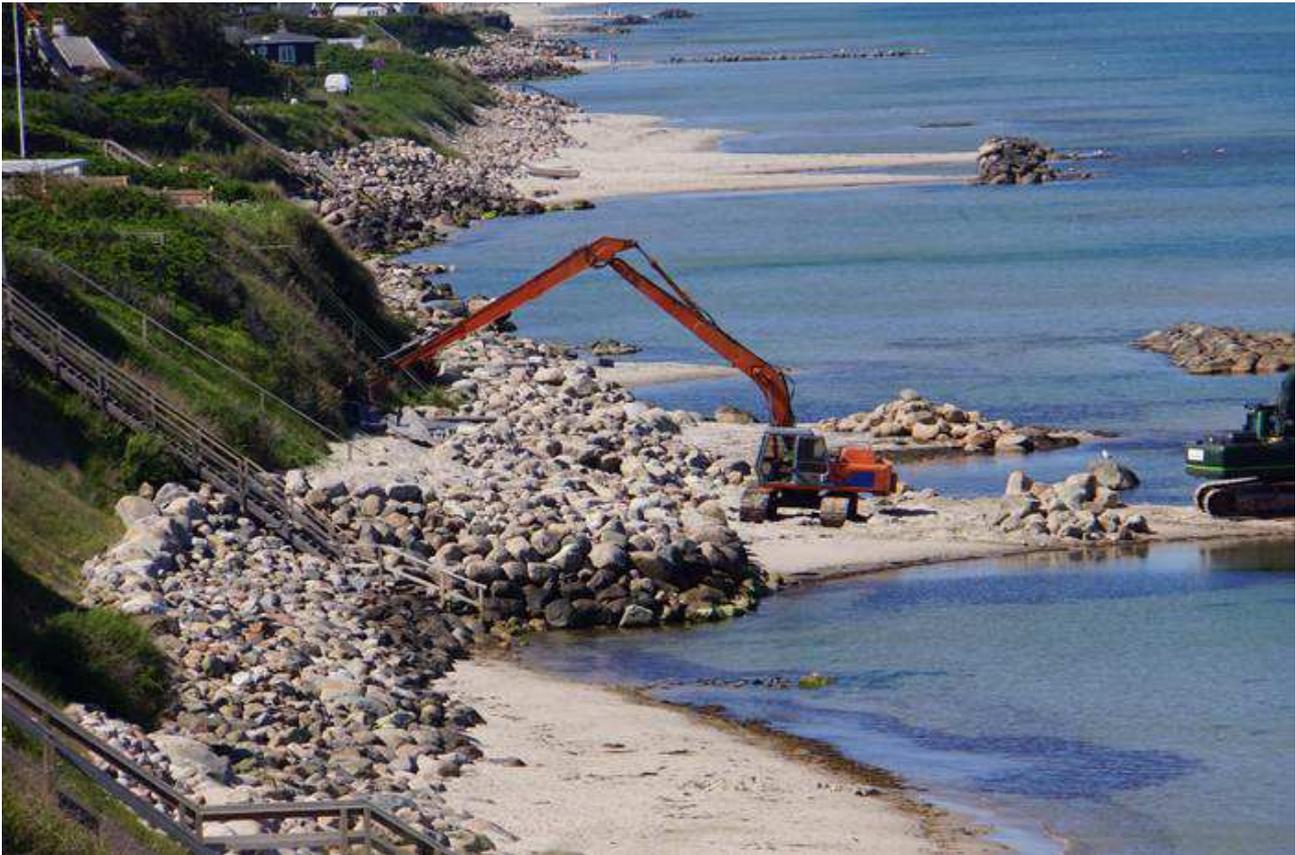
Figure 11 Armoring of the coast

Active coastal protections, defined as focused on solving a deficit in the sediment budget, are not implemented yet. This has resulted in an armored coast (Figure 11), where the coastal profile has steepened during the years, with a significant loss in beach sediments and a change in habitats.

There are huge maintenance costs for the existing coastal protection structures because of this steepening of the profile. Steepening causes larger depths in front of the shoreline and hence bigger waves that hit the coast. The sediment volume of the beach in front of the revetments is gradually reducing and has completely disappeared along some stretches.

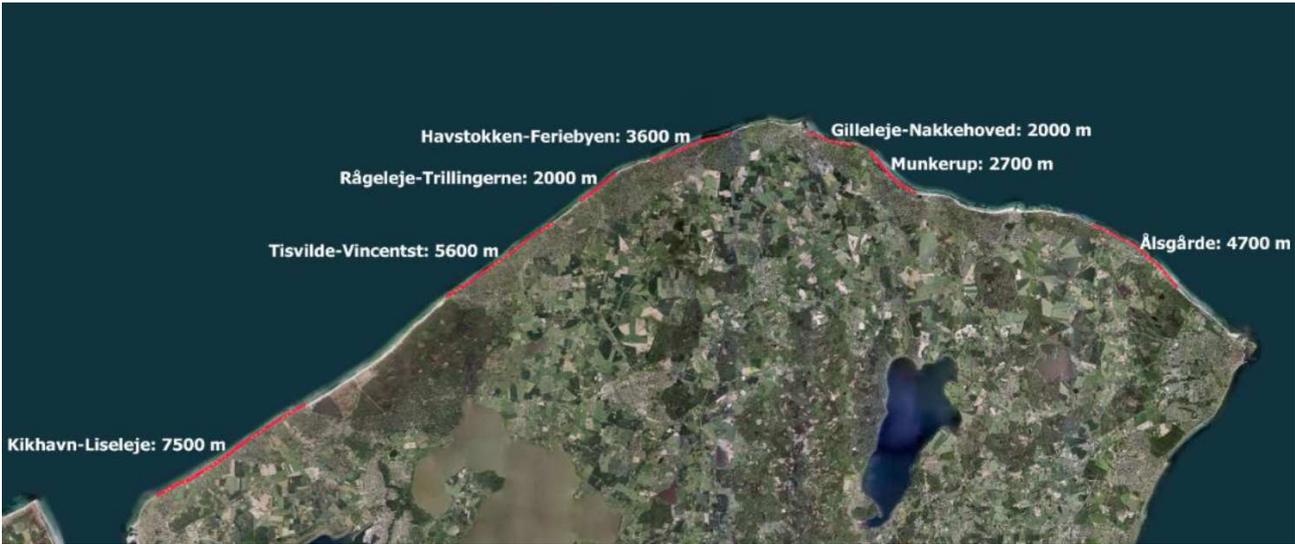
Figure 12 Proposed beach nourishment stretches

The municipalities have the right to enforce coastal protections schemes for longer stretches, either on their own initiative, or based on a contact with a group of landowners. The three municipalities along the northern coast of Zealand, Helnæs, Gribskov and Helsingør, have taken such an initiative. The main objective for them is to start with beach nourishments that compensates for the chronic erosion by the wave-driven longshore sediment transport. The nourishment stretches can be seen on Figure 12.

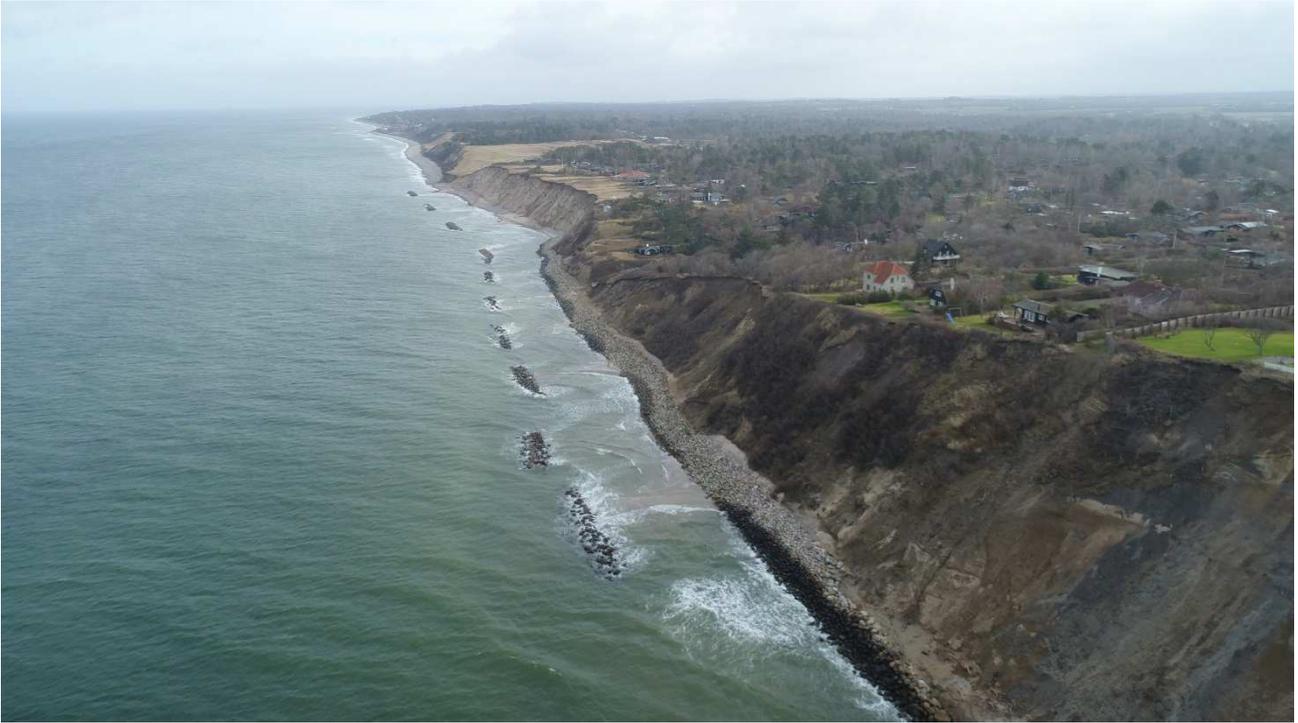
Figure 14 Moraine cliffs, coastal protection with Heatherhill in the background

The coast around Heatherhill shift from a clayish moraine cliff to a sandy cliff (Figure 13 and Figure 14). The cliffs of Heatherhill were stable for many years until the leeside erosion from upstream coastal protection reached the area. The Figures clearly show that a lot of passive coastal protection has been constructed. This has resulted in a sediment starving profile with only one nearshore bar in general.

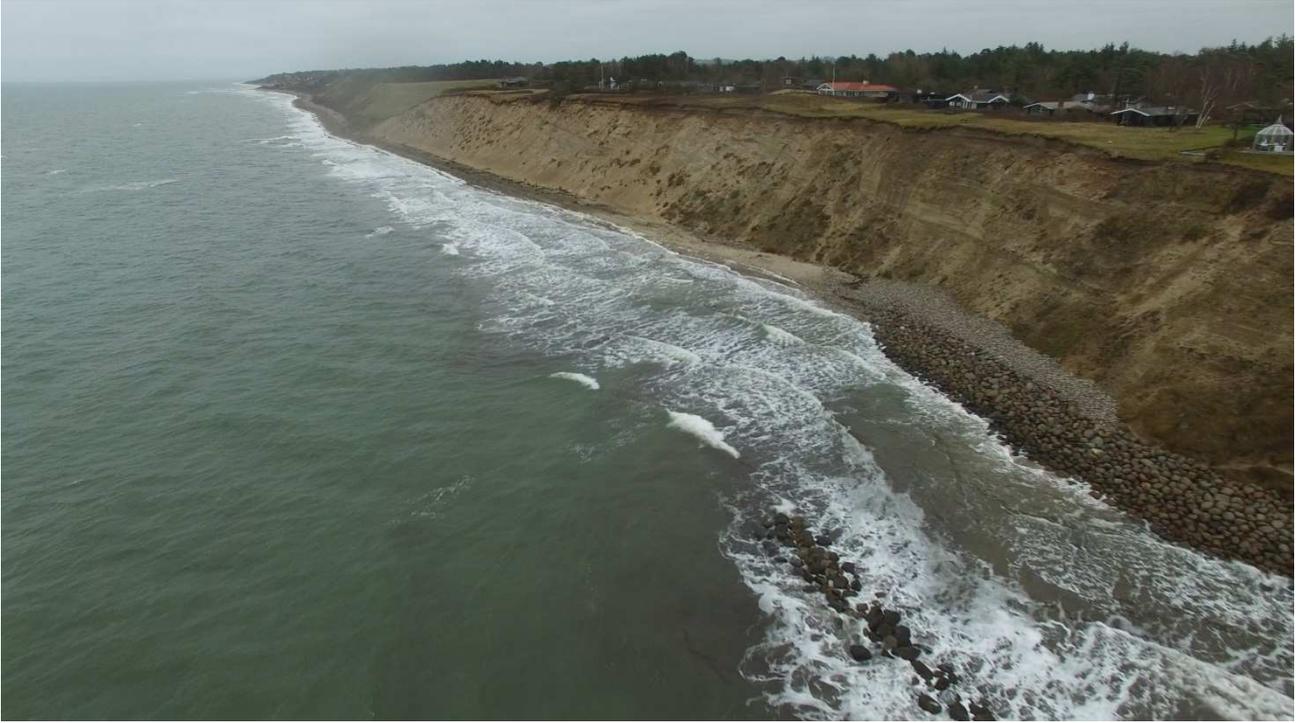
Figure 15 Heatherhill in December 2016 before the construction of the shore parallel breakwaters

Recently, three shore-parallel breakwaters have been constructed (Figure 15 and Figure 16). Additional beach nourishments will be done regularly to counteract for the chronic erosion.

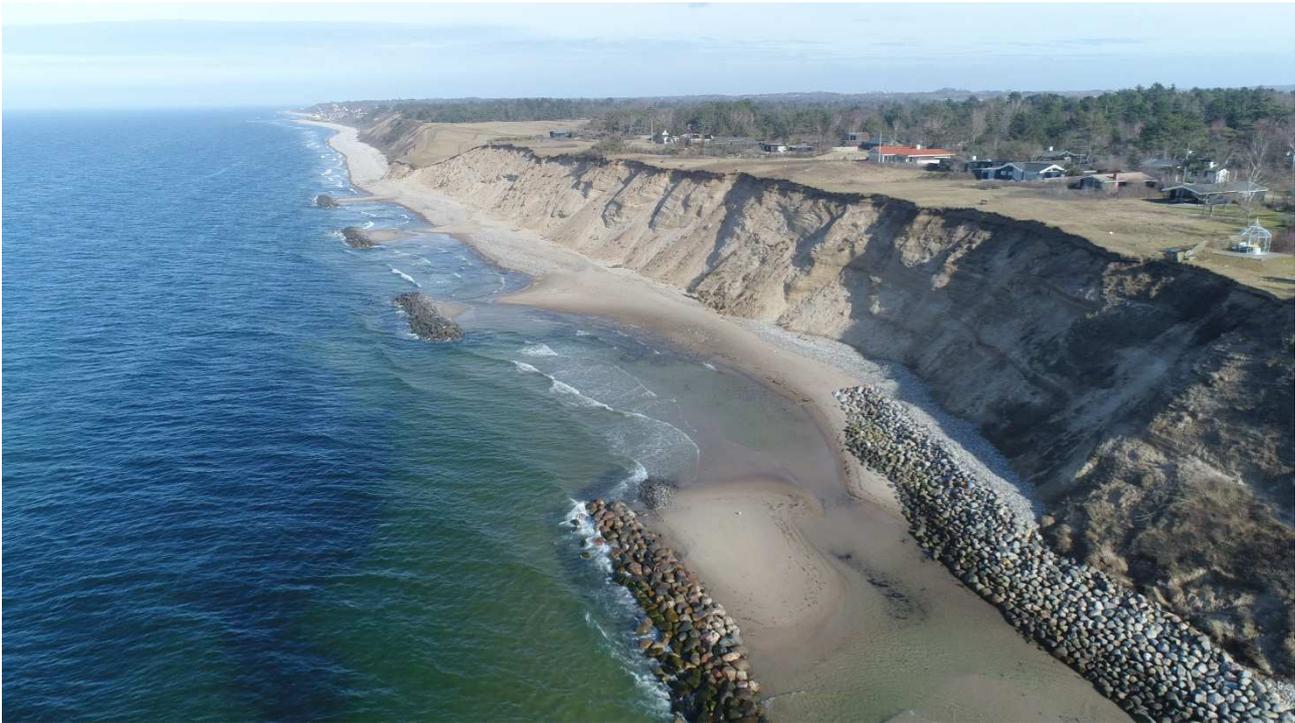
Figure 16 Heatherhill in March 2017 after the construction of the shore parallel breakwaters

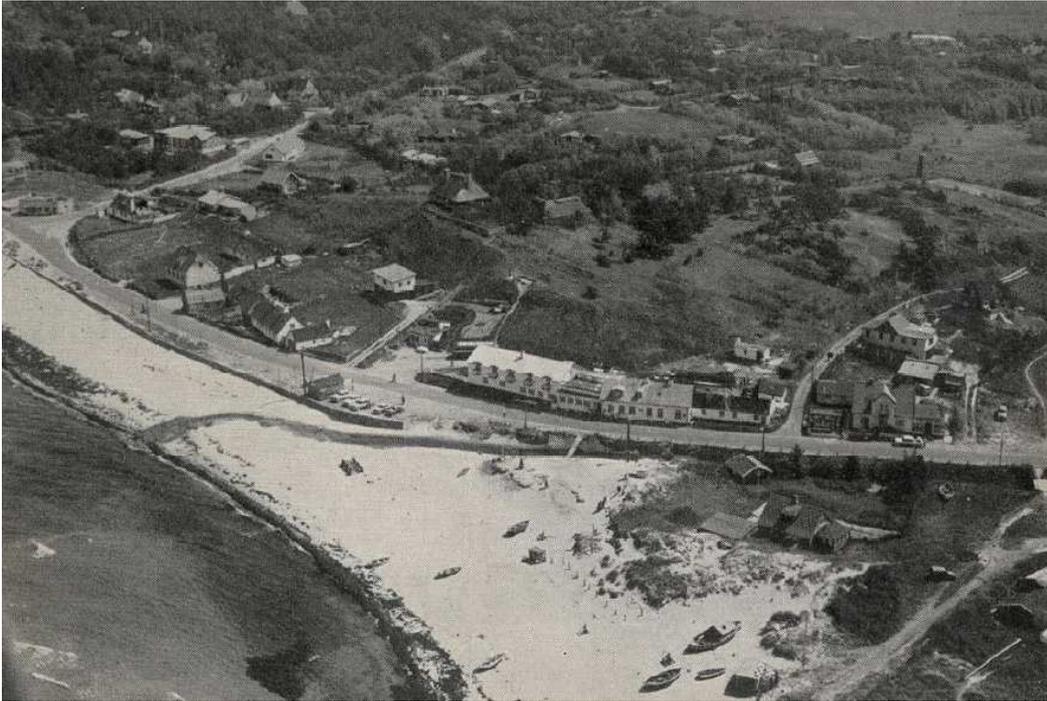
Figure 20 Rågeleje in circa 1950

Rågeleje is one of the few stretches where there is easy access to the beach and the coastal town has been present for long. Rågeleje used to have a wide nice beach (Figure 20) which gave it a status as an attractive recreational coastal town. However, a breakwater was constructed around 1918 to give shelter for fishing boats. This introduced a clear lee side effect. Erosion of the beach in combination with reflection on the vertical concrete wall resulted in a low gravel beach.

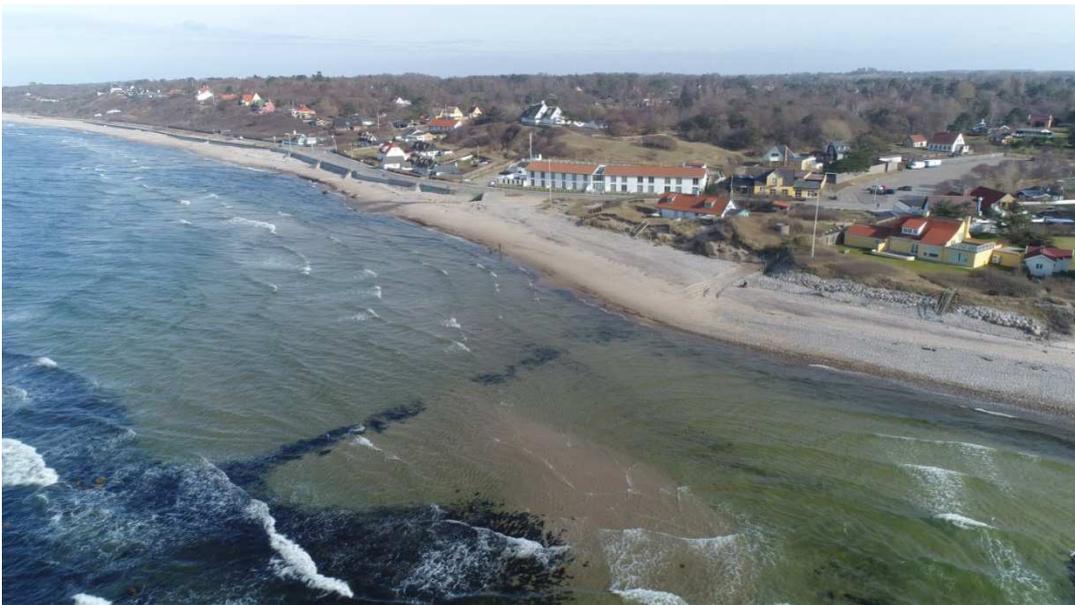
Figure 21 Rågeleje as it is today with less recreational value

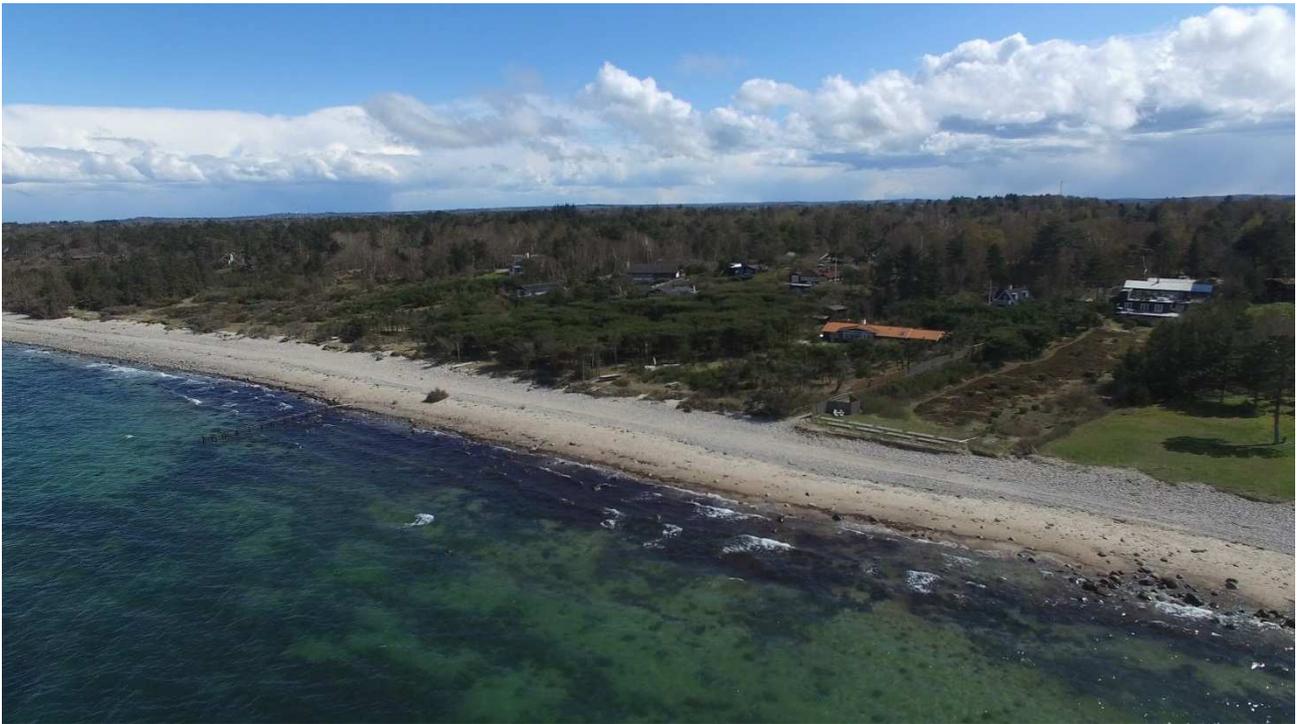
Figure 23 Smidstrup beach

Smidstrup beach is a natural behaving beach (Figure 22 and Figure 23) which has been quite stable over the last 20 years. The beach protection line as defined in the planning law has prohibited that houses were built close to the coastline. Therefore, there are no coastal protection measures in this area.

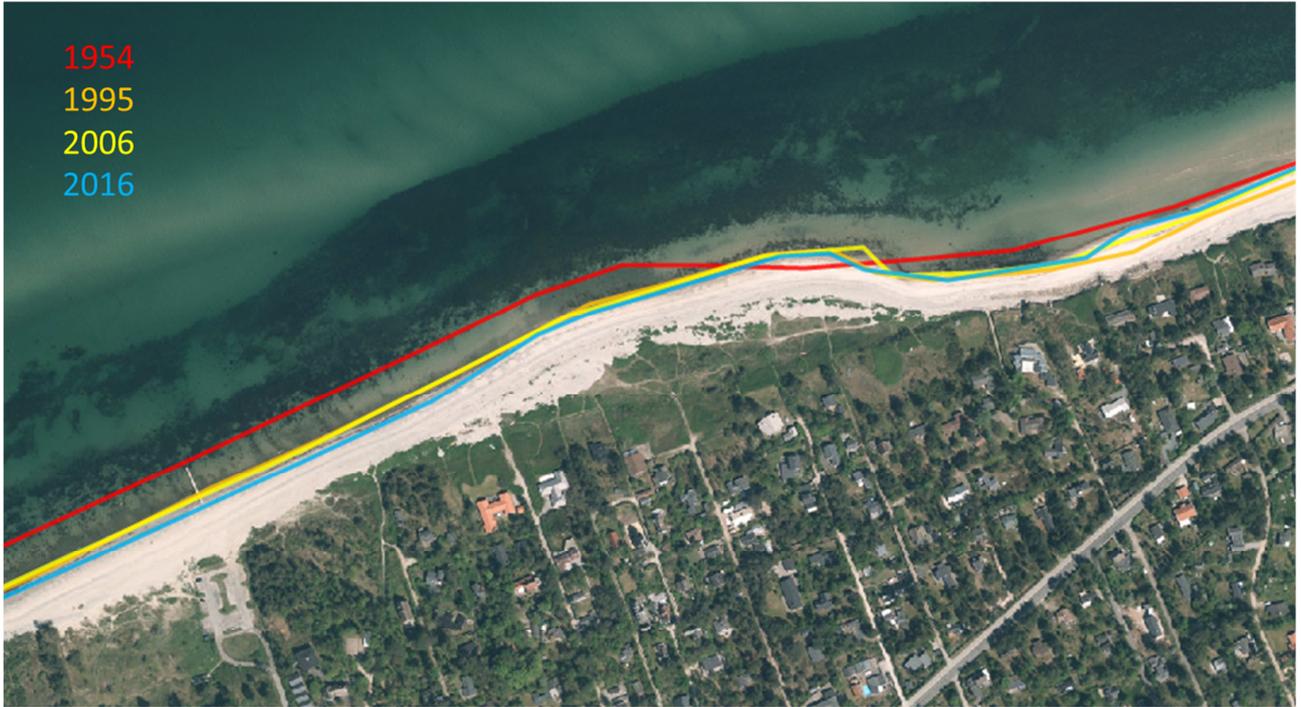
Figure 24 Development of the natural behaving coast at Smidstrup

For many years a coastline undulation has been present in the area. The undulation consists of sand and some gravel. The morphological shoreline development from 1954 to 2016 can be seen in Figure 24. In spring 2017, the undulation was more prominent (Figure 25) and waves were refracting along it.

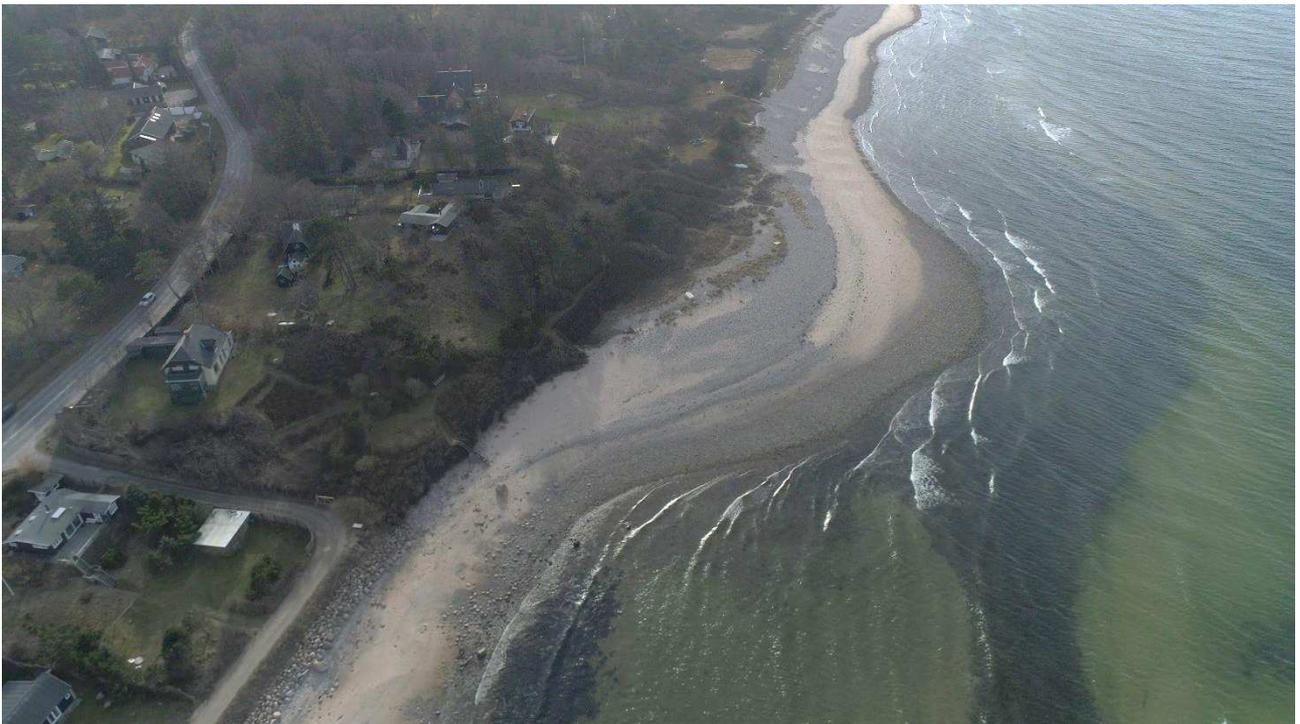
Figure 25 Waves refracting around beach undulation

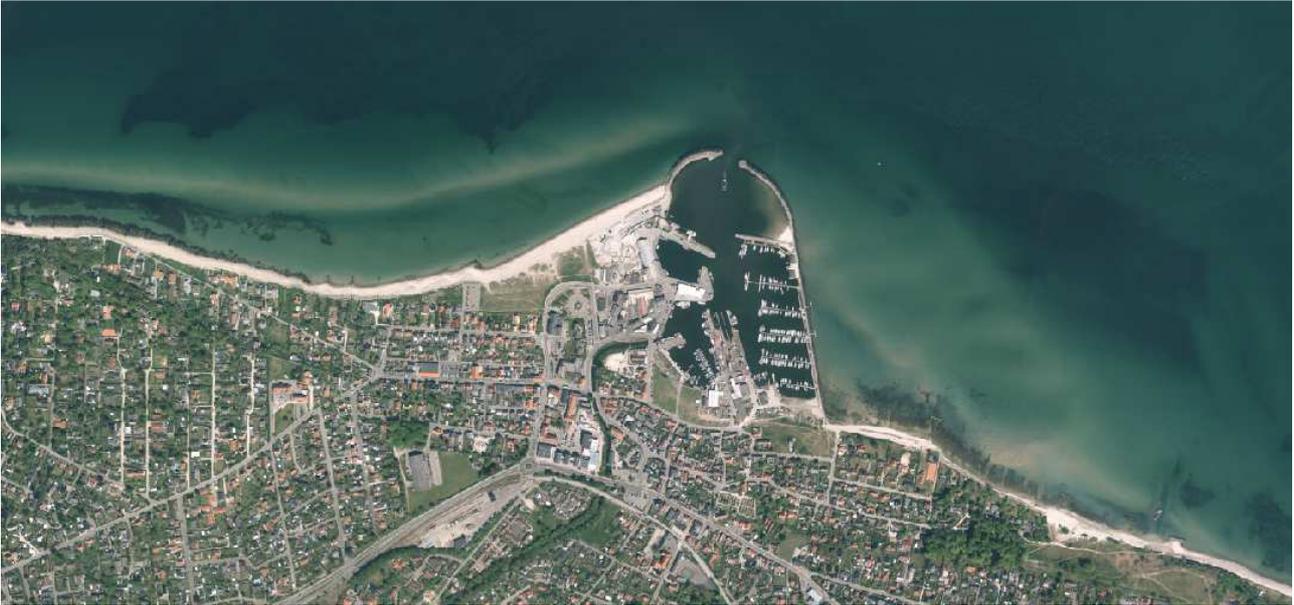
Figure 26 Gilleleje harbor

Gilleleje harbor acts as a huge groin, and the leeside effect is clearly visible (Figure 26).

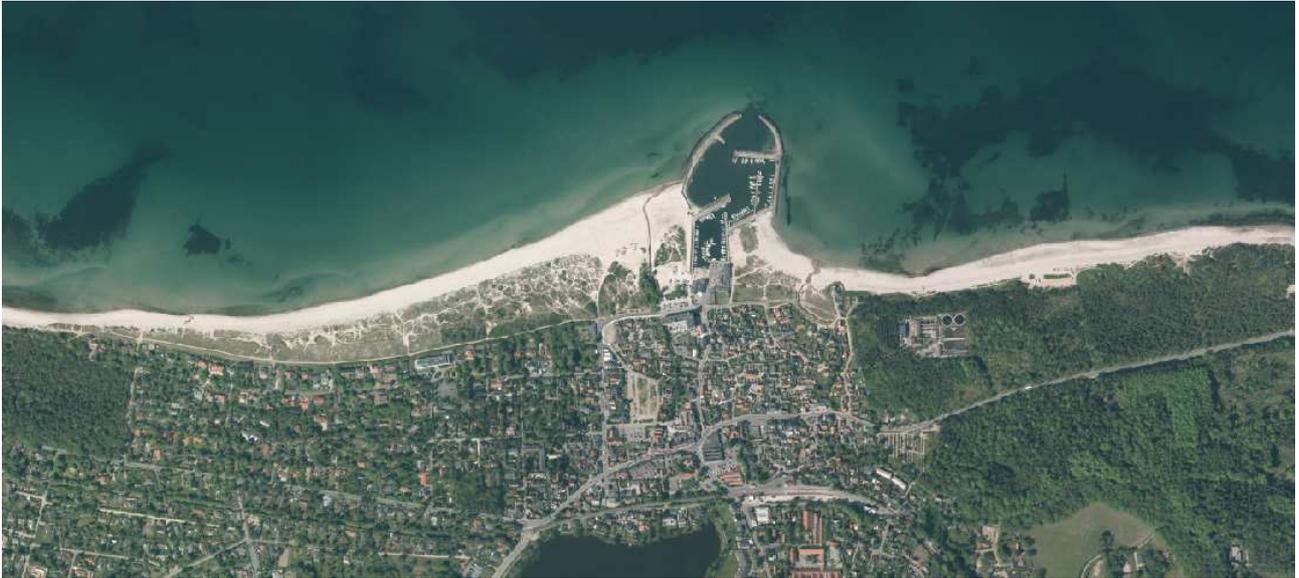
Figure 28 Hornbæk harbor

Hornbæk harbor is placed on a more sheltered stretch of the North Zealand coast (Figure 28). The harbor was completed in 1880 and almost completely financed by people that owned holiday houses, because they felt sorry for the fishermen that had to drag their fishing boats up on the beach. A huge leeward side accumulation of sand can be seen. This has caused aeolian transport from the beach into the harbor basin. Marron grass and brush wood fences are used to stabilize the dunes in order to keep the sand in the area.

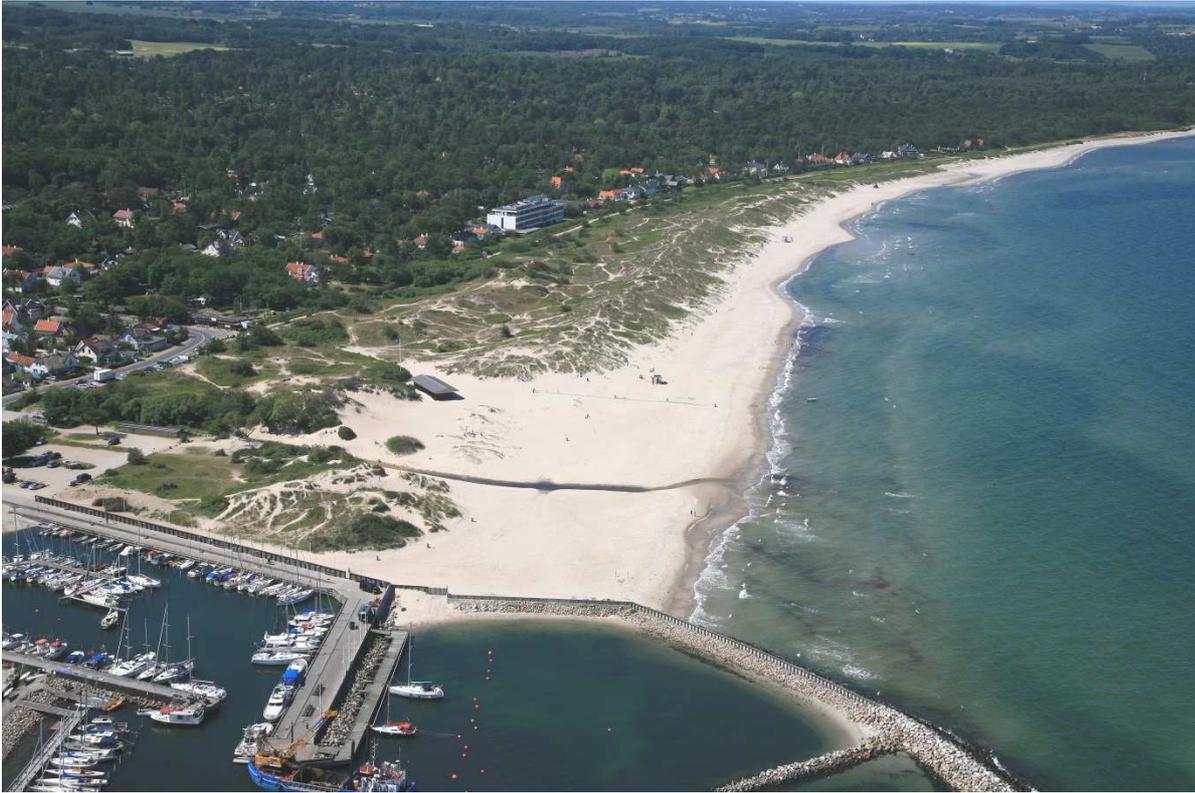
Figure 29 High dunes and wide beach west of Hornbæk harbor

This stabilization has led to unusually high dunes west of the harbor (Figure 29), and constant management of the aeolian transport is necessary. The beach is very attractive to visit and the dunes have a huge recreational value.

Bypass of sediment from the west to the east is regularly done. The bypass volume is approximately 20.000 m<sup>3</sup> and the sediment is placed on the bar at the leeside of the eastern harbor mole.
