BUILDING WITH NATURE PILOT SANDY FORESHORE HOUTRIBDIJK DESIGN AND BEHAVIOUR OF A SANDY DIKE DEFENCE IN A LAKE SYSTEM

Henk Steetzel¹, Fokko van der Goot², Jasper Fiselier³, Marieke de Lange⁴,
Ellis Penning⁵, Robbin van Santen⁶ and Vincent Vuik⁷

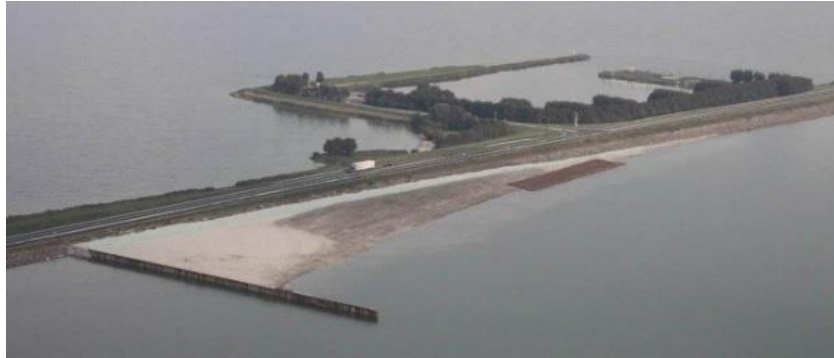
Figure 1 Overview of pilot section direct after construction in September 2014 showing the sheet pile wall and the plot in which clay is mixed in the top layer of the sandy test section (photo: Mennobart van Eerden).

Figure 1 presents an overview of the initial lay-out of the triangular shaped foreshore. The foreshore test section has a length of about 450 m and was constructed in the summer of 2014.

The pilot consists of a sand body of approximately 70,000 m³, varying in width and height and is enclosed by a sheet pile wall on the down drift side. The maximum width of the initial beach above the mean water level next to this wall is about 90 m. For the cross-shore profile slopes in the order of 1 in 25 to 30 were designed although the actual construction resulted in somewhat steeper slopes, especially in the lower part of the underwater profile. Locally sourced sediment (D_{50} ranging from 200 to 600 μm per shipping load yielding an overall average D_{50} 270 μm) was used for construction. Furthermore, a long wind screen next to the dike was installed to prevent sand to be blown towards the road.

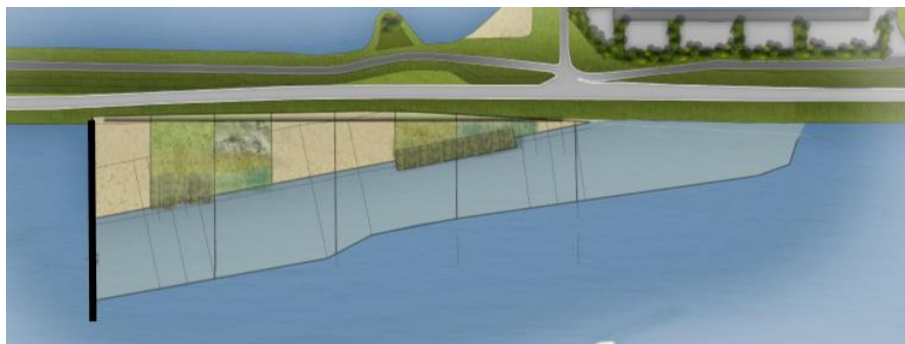
Figure 2 Lay-out of the pilot section with four sections of each 100 m width and each section planted manually, while the other half is left to develop on its own. The willow faggots matras is positioned in the right-hand smaller section.

Figure 2 shows the 100 m wide sections in which either vegetation was been planted manually to kickstart vegetation development or a spontaneous development of vegetation was foreseen (Penning et. al., 2015).

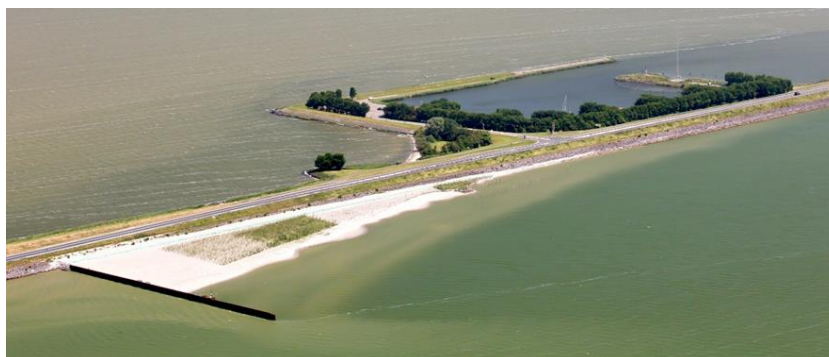
Figure 3 Overview of pilot section direct in June 2016 (two years after construction) showing the adjusted contour as well as the well-developed vegetation in specific plots of the test section (photo: Jurriaan Brobbel).

Starting with the overall development, in addition to the 2014 photo (see Figure 1), another aerial photo has been taken in June 2016 (see Figure 3). As can be observed, the vegetation development differs depending on the initial conditions, with the planted sections clearly visible. The one with mainly willow species and clay mixed in the soil shows a denser and greener vegetation. The waterline itself shows some interesting discontinuities due of wave attack from oblique directions just prior to the moment this picture was taken.

vegetation was not able to develop at the water line itself. Moreover, vegetation is just not able to stabilize the sand in such a highly dynamic region. Consequently, vegetation remained only present at the higher, dry part of the foreshore.

Furthermore, the willow faggots matras on the outer extent of the test section (upper-right in the figure), installed to protect the initial vegetation proved not to be robust enough and were destroyed during storm events. At this moment (spring 2017), all willow matras have been destroyed completely resulting in one long coastal sandy stretch without solid interruptions along the water line. The remaining willow vegetation in this section was not capable to withstand the hydrodynamic forces, and is also disappearing.

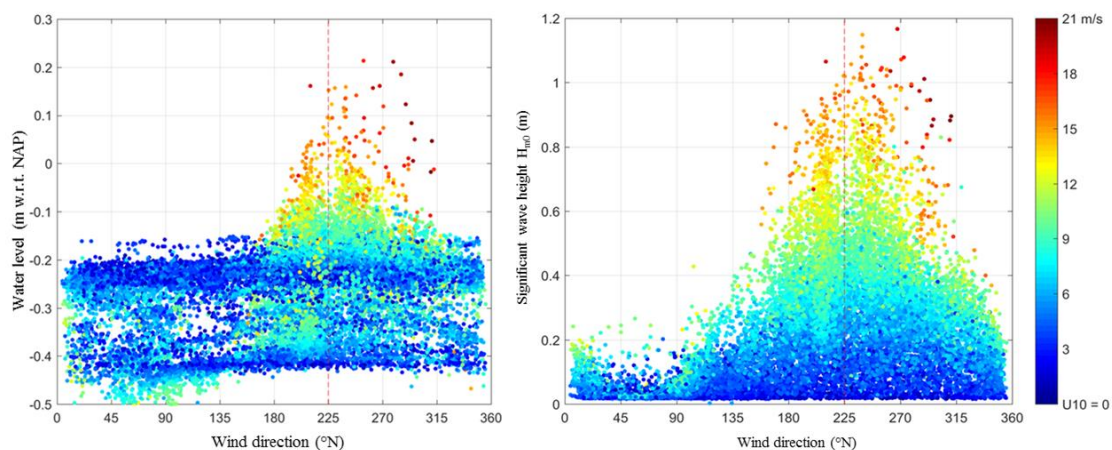
Figure 4a Relation between the water level and wind direction; Figure 4b Relation between the significant wave height and wind direction on the right-hand side, including colours indication the wind velocity. The vertical dashed lines refer to the cross-shore orientation of the pilot section at 225° N.

Figure 4a shows the relation between the water level and wind direction. Water levels vary roughly between NAP-0.4 m in winter (with NAP referring to the vertical Amsterdam Ordnance Datum) and NAP-0.2 m in summer. Wind set-up during storms can lead to water levels up to NAP+0.2 m for wind directions perpendicular to the average shore line orientation, e.g. south-western winds.

South western winds generate also the highest waves on the test location as can be seen in Figure 4b, showing the relation between the significant wave height and the wind direction. Significant waves heights up to 1.2 m were recorded at the site.

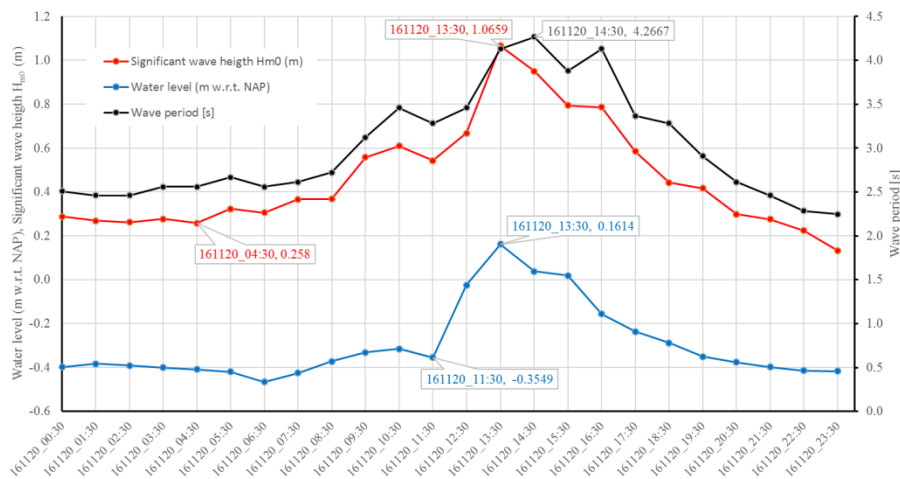
Figure 5 Overview of observed conditions during the autumn storm of November 20, 2016 showing the development of the water level (blue line), the wave height (red line) and the wave period (black line).

Since the hydrodynamics are monitored, the characteristics of an individual storm can be studied in detail. As a typical example, the measured water level and wave conditions during the autumn storm of November 20, 2016 are presented in Figure 5.

As can be observed, this afternoon storm can be characterized by a rapid rise of the water level starting at about NAP-0,35 m and within two hours reaching a 0.5 m higher level of NAP+0.15 m. This swift build-up coincides with an increase of both the wave height and the related wave period. In this specific case, the maximum wave height was 1.05 m being one of the major events observed so far.

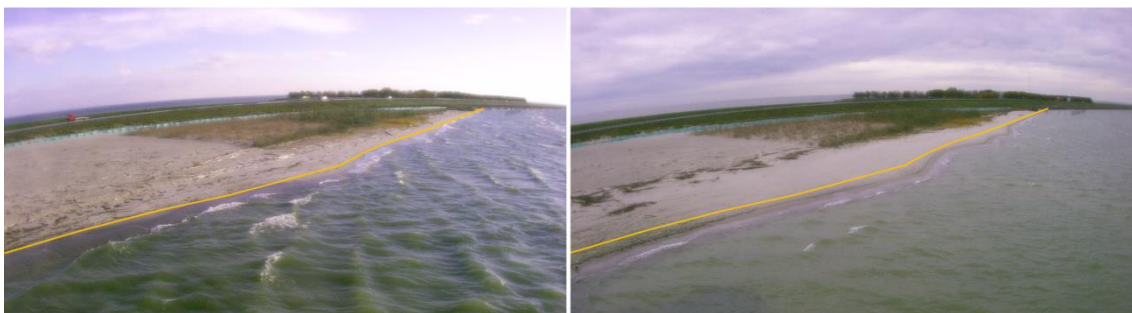
Figure 6a View on the pilot section on November 19 before the storm; Figure 6b View on November 21 after the autumn storm. The yellow line indicates the pre-storm position of the waterline on November 19, 2016.

An indication on the effect of the storm is shown in Figure 6 in which both a photo on the day before as after the storm is shown. From the yellow line, indicating the pre-storm waterline position from Figure 6a, it can be concluded that the impact of the storm, apart from ‘cleaning the higher beach’, was limited. Apparently, the initial pre-storm profile already had a stable shape.

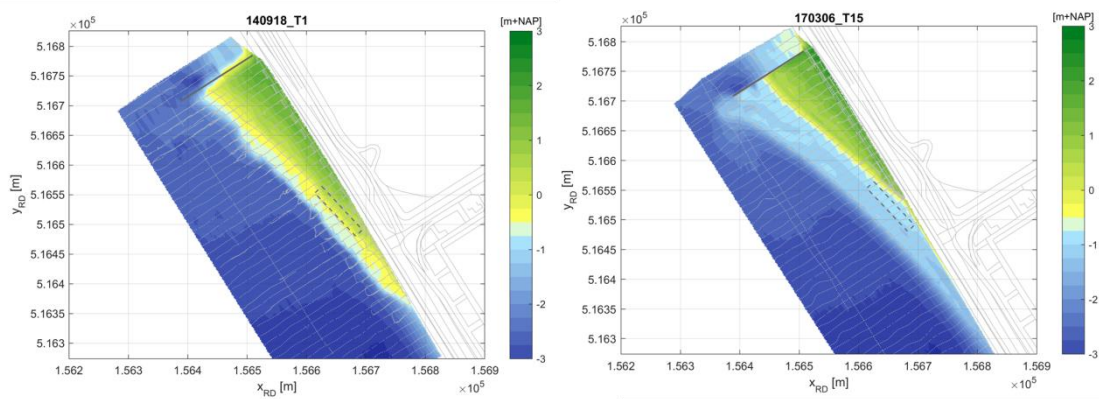
Figure 7a Development of the bathymetry with the levels at the start of the monitoring programme on September 18, 2014; Figure 7b The result of the most recent measurement on March 6, 2017.

Up to now, 15 measurements campaigns have been performed to assess the morphological development of the test section. A basic result is presented in Figure 7a which shows both the initial bottom topography at the start of the monitoring campaign on September 18, 2014, as well as the latest bottom levels as present on March 8, 2017 in Figure 7b. The sheet pile wall is located on the upper-left boundary of the test section and is intended to keep the sand body in place.

In the initial situation, the section with the willow faggots matrass, as indicated by the small dashed box in the narrower part of the test section, is positioned around the still water line. The cross-shore bathymetry at this moment shows a distinct vertical step between the higher part of the sand body and the original lake bottom at around NAP-2 m.

Due to hydrodynamic forcing, the bottom levels in the nearshore zone develop until a more or less stable under water shape is reached as denoted by the light blue area in Figure 7b. This area seems connected to the presence of the sheet pile wall in the upper left part of the test section.

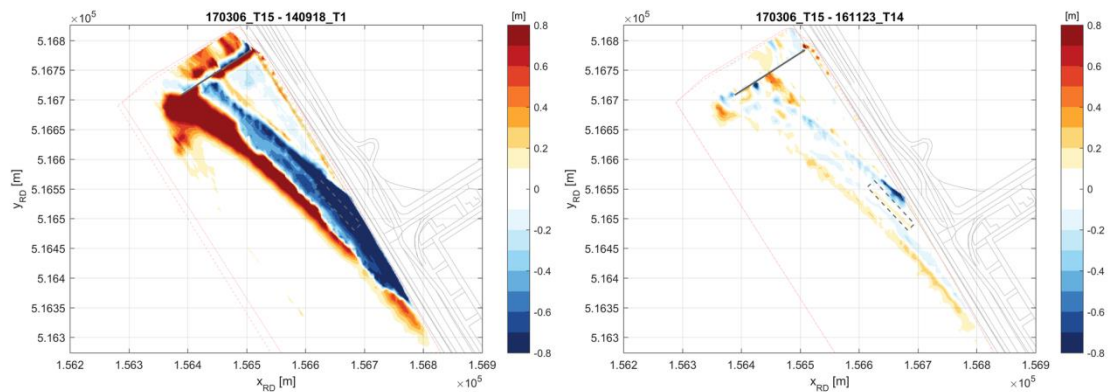
Figure 8a Changes since the initial situation (March 6, 2017 minus September 18, 2014);

Figure 8b Difference compared to the most recent measurement (November 23, 2016).

The actual development can be illustrated also by examining the differences between individual measurements. Typical examples are provided in Figure 8a showing the changes since the first measurement and the changes during the last interval (Figure 8b).

Figure 8a shows that the sediment seems redistributed in especially cross-shore direction yielding a blue eroding (blue) area around the original water line (see Figure 7b), as well as deposition (red) area in front of it. The north-western extent of the outer contour of this accretion logically corresponds with the location of the end of the sheet pile wall and consequently indicates that several hydrodynamic processes will play a role. Looking in more detail at the actual water line as a boundary of the upper dry part of the test section the indicates that the development of this part of the profile results in a rather straight contour which is probably affected by the wave attack only.

The most recent changes as shown in Figure 8b show that the morphological development has more or less stabilized. Because of especially the storm conditions in the last part of the monitoring period the characteristic contour of the upper part of the profile shows a minor anti-clockwise rotation with an eroding (blue) area in the south-eastern section and an accretion area (red) in the north-western part. The gradual development of the lower part continues showing especially a small accretion zone in the south-eastern part.

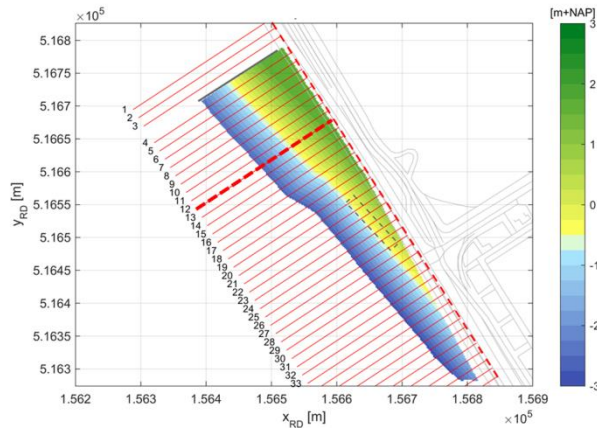
Figure 9 Overview of measurement trajectories used for the morphological recordings with cross-shore profile no 12 indicated by the red dotted line.

The bottom topography is based on the results of a large number of measurement tracks as shown in Figure 9, applying the original design of the test section as a background. In this plot, also the location of profile no 12 is shown which can be considered as a characteristic profile located in the central part of the test

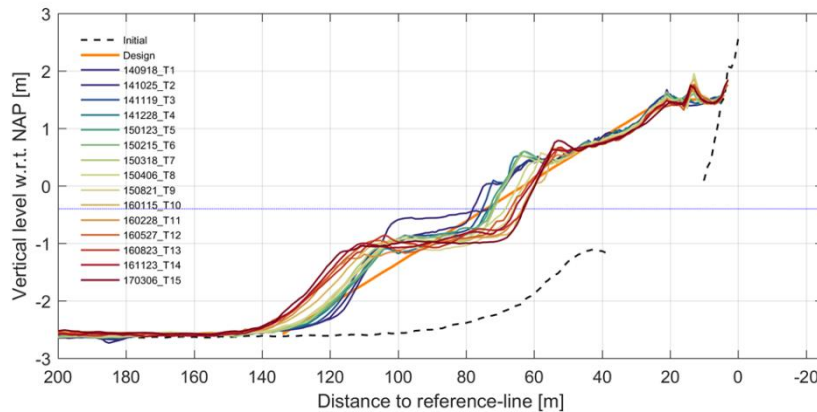
Figure 10 Development of the cross-shore profile at location no 12 until March 6, 2016, since the start of the measurement campaign, including the original design profile and the initial local bottom topography (T1).

The development of the cross-shore profile at this location is presented in Figure 10 with the blue horizontal line indicating the water level during the winter season (NAP-0.4 m).

A comparison of the most recent profile (measurement T15) with the initial design (denoted in the figure by the straight slope) shows that the rough shape of the most recent profile, apart from of course the varying cross-shore slope, still resembles the initial profile shape. At some levels material is eroded while accretion is present at other levels. A significant nett loss of material does not occur.

The initial development, between measurement T1 and T2, shows that the part of the constructed profile close to the water line (in between cross-shore position 80 and 100 m) has eroded almost immediately. Based on this behaviour the conclusion can be drawn that the initial shape of the lower foreshore is not that important. Far more important is it to apply the correct amount of sand to construct the design profile.

Starting from measurement T2, the typical shape of the cross-shore profile remains more or less unchanged up to the most recent measurement (T15). This typical profile consists of a rather steep slope (order 1 in 10) around the waterline including a landward connected swash berm up to approximately NAP+0.5 m and a slightly gentler slope of the lower zone below the NAP-1.0 m level. In between these two slopes, a more or less horizontal plateau is present of which the width depends on the alongshore position as already shown in Figure 7b. Other features to be observed are the gradual reduction of the bottom level in the higher part of the profile (between cross-shore position 20 and 40 m) due to compaction of the lower layers under the foreshore nourishment and the local increase in the bottom level (between cross-shore position 10 and 15 m) due to the presence of the windscreen.

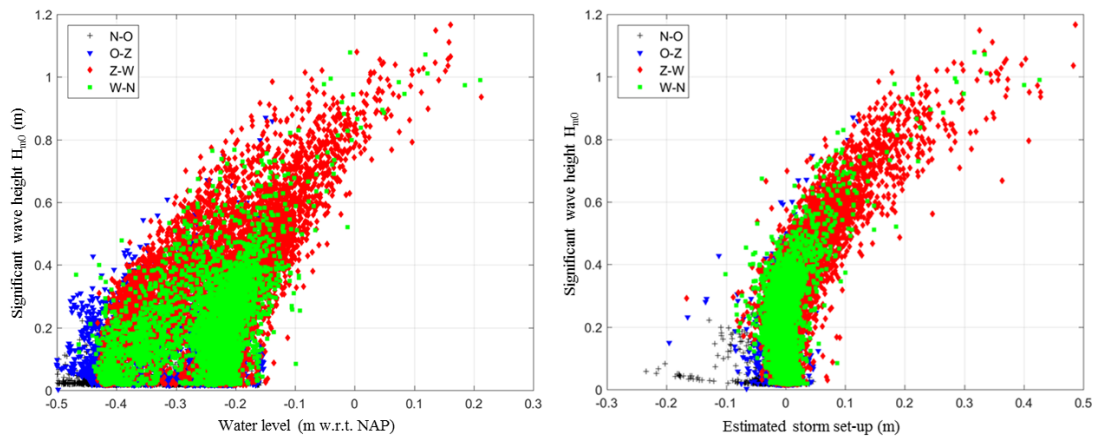
Figure 11a Overview of all combinations of water level and wave heights; Figure 11b Overview of all combinations of the estimated storm set-up and wave heights all for four sections of wind direction.

As already indicated by the time series during the storm, events with higher waves correspond with events with higher water levels. This correlation is shown in Figure 11a by applying all combinations of the actual water level on the horizontal axis and the observed wave height on the vertical axis. Wind from south-westerly direction is responsible for the higher waves (see also Figure 4).

If the storm set-up is computed from the difference between the actual water level and a moving average of the water level over a period of a week, Figure 11b is obtained showing a clear correlation is between the storm set-up and the wave height. For the storm event presented in Figure 5 this yielded a 0.5 m set-up in combination with a significant wave height of 1.05 m (see second highest data point in the upper right corner of this figure).

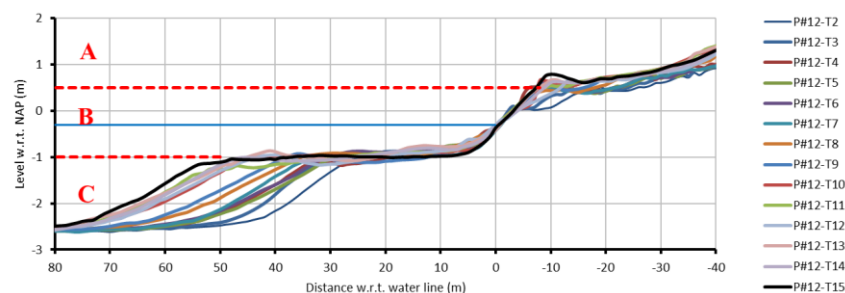
Figure 12 Development of the cross-shore profile shape at location 12, plotted relative to the intersection with the NAP-0.3 m level. Including the definition of the upper (A), middle (B) and lower layer (C).

In Figure 10 the development of the cross-shore profile in location 12 was already addressed. From this it was concluded that a more or less stable cross-shore profile was developed during the initial phase of the monitoring programme. Figure 12 shows the development of the shape of the profile by plotting the various profiles starting at this location starting from measurement T2 as a function of the distance to the NAP-0.3 m contour representing the average water level in this lake.

Apparently, the profile shape around the waterline is developed already in the initial phase yielding a straight slope of about 1 in 10. In time, both the level of the swash berm as the width of the near horizontal plateau increases gradually.

Apart from the width of the plateau, especially its more or less fixed level is an interesting phenomenon. Additional analyses indicate that this level is related to the specific correlation between the water level and the wave height at this location as already shown in Figure 11b. The increase in penetration depth for higher waves is compensated by an increase in the water level, yielding a minimum wave bases as a result.

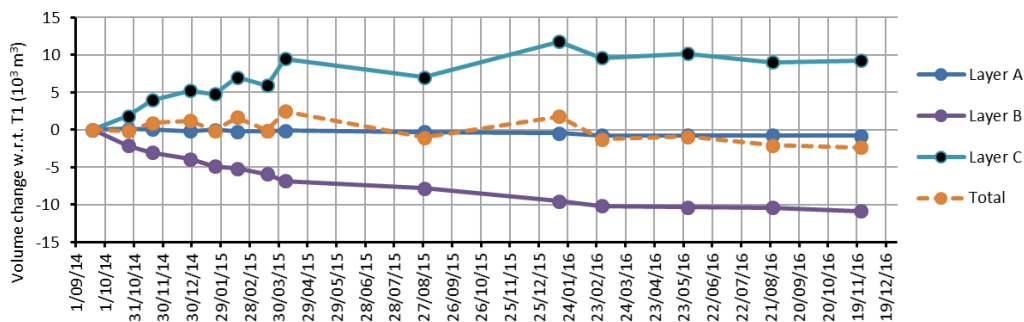
Figure 13 Development of the volume in the distinguished vertical zones with respect to the initial volume (T1).

Based on the typical profile shape three vertical zones have been defined for the analyses of the large-scale development of the sand body. A distinction is made between the upper zone (A) above the NAP+0.5 m level, a lower zone (C) below NAP-1.0 m and an area in between (B) as already illustrated in Figure 12. Figure 13 presents the development of the volume in these three layers, which shows that the decrease in volume in the middle layer is balanced by the increase of the volume present in the lower layer.

From this it can be concluded that cross-shore processes dominated the development of the profile in the initial phases, allocating volume from the middle (B) to the lower level (C). It should be noted that due to the absence of tides, that the losses to deeper sections of the profile are more or less irreversible. Only erosion takes places and there is hardly built up during calm weather as can be observed along the coast. The erosion itself is assumed to be originated from the presence of the sheet pile wall, that steers a stable lay-out and position of the lower layer.

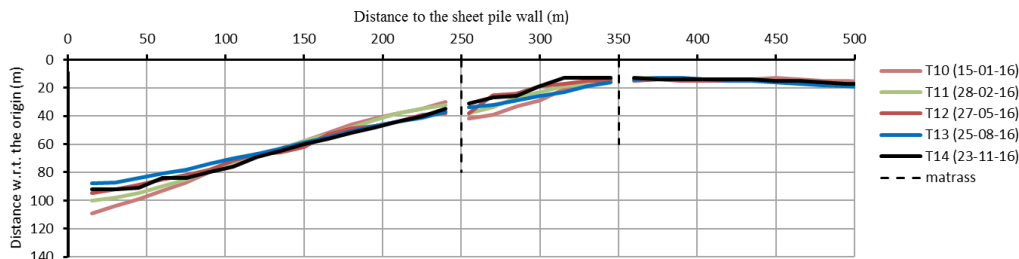
Figure 14 Development of the longshore position of the contour representing the middle zone.

Applying the position of the NAP-0.3 m contour as an indication of the position of the B-layer, the development of the longshore shape of this contour can be examined. A typical result of this elaboration is shown in Figure 14. Up to measurement T12 the shore line in the area left of the matras construction showed a wave-induced rotation depending on the storm characteristics during the preceding measurement interval. After the matras was destroyed, this rotating mechanism holds for the whole length of the test location.

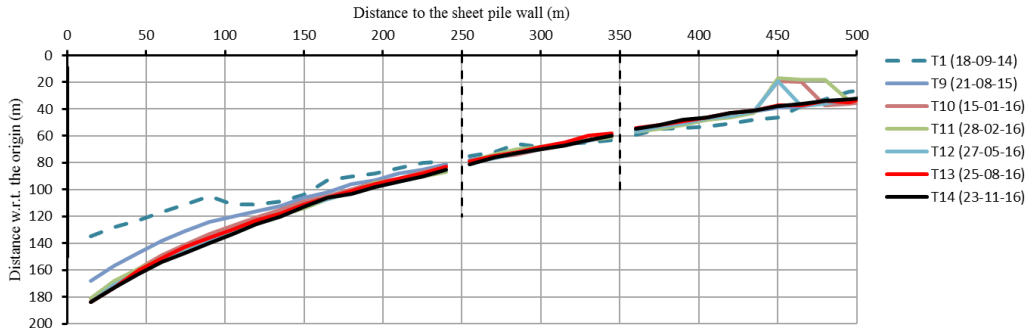
Figure 15 Development of the longshore position of the contour representing the lower zone.

A comparable procedure using the NAP-1.5 m contour produces insight in the development of the outer contour of the lower zone. This evolution is shown in Figure 15.

From this it is concluded that the development of the lower part of the profile is attached to the outer extent of the sheet pile wall. Probably, the deflecting wave-induced current next to wall combined with the large-scale circulation current present in Lake Marken is responsible for the development of this lower layer. Therefore, the width of the plateau depends on the more or less fixed position of the lower layer (Figure 15) in combination with the temporary position of the upper layer (see Figure 14).

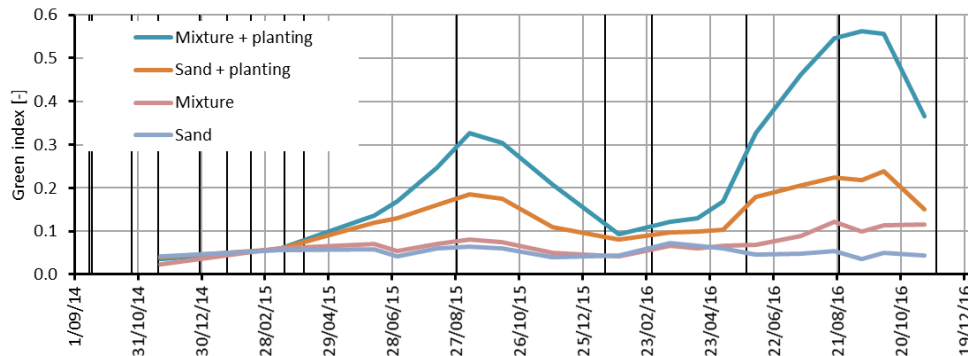
Figure 16 Development of averaged normalized difference vegetation index (NDVI) for specific plots representing zones with and without planting combined with sand or a mixture of sand and clay.

The growth of the vegetation on the test location is monitored in detail during visits of the pilot location twice a year, as well as by analysing and processing of information obtained from Spot-satellite images. Based on latter information, the so-called normalized difference vegetation index (NDVI) has been quantified for specific sections of the test section for a series of selected images. This is a measure for the green index and thus the density of the vegetation. A typical result of this procedure is shown in Figure 16 in which the development of the NDVI-index in time is presented until November last year.

In this case, a comparison is made between the rates in four distinct areas, namely zones with and without planting combined with zones with only sand or a mixture with clay. Apart from the seasonal variation in density, a gradual increase in the density of the vegetation during spring and summer and decrease in fall and winter, both the advantages of planting (relative to a spontaneous development of vegetation) and the application of a mixture become clear. The density reaches higher maximum values in the second season (2016), reflecting that vegetation needs at least two growing seasons to develop.
