## BEACH EROSION AND STRUCTURAL DAMAGE BY HIGH SWELL WAVES

### Abstract

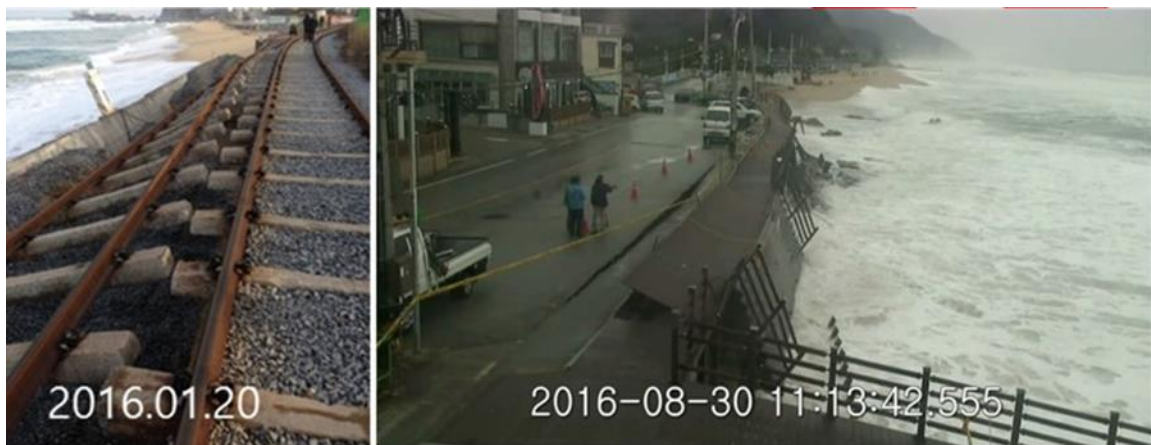
Figure 2 shows the damaged area of Jeongdongjin beach. The rail at the beach area at GW29-10 in Figure 2 was collapsed on January 20, 2016 and the coastal deck was broken on August 30, 2016. In both cases, significant high swell waves came to the east coast of Korea for 2~3 days. On January 20, the second day of the high swell wave attack, the coastal railroad had been collapsed after the waves washed away the beach sands in front of the vertical seawall as shown on the left-hand side of Figure 2. On the other hand, from August 29, 2016, similar high swell waves came to the beach and the coastal deck was collapsed and the road was cracked on the second day of the high swell wave attack as shown in the right-hand side of Figure 2. The photographs evidenced that the high swell waves attacked and gave a damage to the different area during the different seasons, summer and winter.

Figure 2. Structural damages in the northern (left) and southern (right) sides of the Jeongdongjin beach.

Especially, the beach widths decrease by 20m in both northern and southern side of the beach in winter and summer seasons respectively. Therefore, the filed observation results show that the beach width decreases due to the longshore sediment transport in the particular season and then the high swell waves attack the eroded beach so that the coastal structures on the beach were destroyed. This mechanism can be applied to the case of January 20 and August 30 in 2016.

Third, when the high swell waves come to the beach, the coastal structures on the narrow beach in particular season are vulnerable. Therefore, it can be found that the railroad in northern side of the beach was collapsed in winter and the coastal deck and road were damaged in summer.

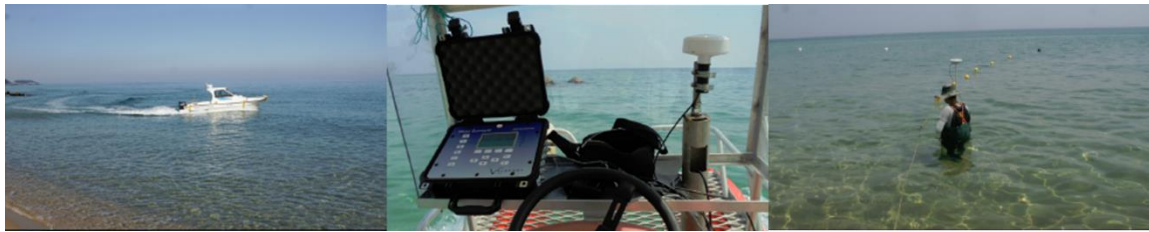
Field observation includes the beach widths, beach profiles, bottom morphology, and incident waves at Jeongdongjin beach. Beach widths and beach profile above the shoreline were surveyed by using portable RTK-GPS. The underwater beach profile and bathymetry were surveyed using a ship mounted single-beam echo-sounder. All surveys were conducted in four seasons to investigate the seasonal morphologic changes. An AWAC (Acoustic Waves and Currents) was installed on the offshore side of the beach to measure the incident wave condition. Figure 3 shows the survey equipment and procedure for beach topography and

Figure 3. Survey procedure for beach topography and bottom bathymetry; a survey vessel (left), single-beam echo sounder and GPS (middle), and RTK-GPS (right).

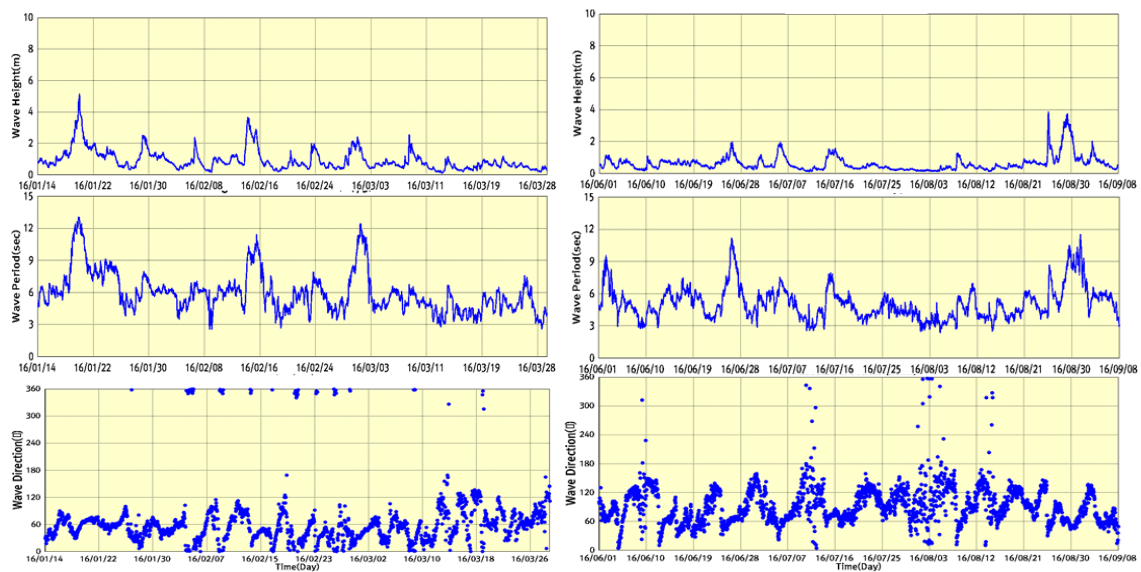
Figure 4 shows the incident wave conditions when the coastal structures were damaged in Jeongdongjin beach during the winter and summer seasons. The left-hand side of Figure 4 shows the wave heights (top), wave periods (middle), and mean wave directions (bottom) from January 14 to March 18, 2016. As shown in the figure, the high swell waves with the significant wave height ( $H_s$ ) of 5.1m and the significant wave period ( $T_s$ ) of 13.0 s came to the beach in sixty degrees. However, in calm wave condition with smaller wave height and shorter wave period, the wave directions were around 45 degrees and 120 degrees in winter and summer respectively.

Figure 4. Incident wave conditions by using AWAC in winter (left) and summer (right) seasons. Top panels, middle panels, and bottom panels indicate the significant wave heights, significant wave periods, and mean wave directions

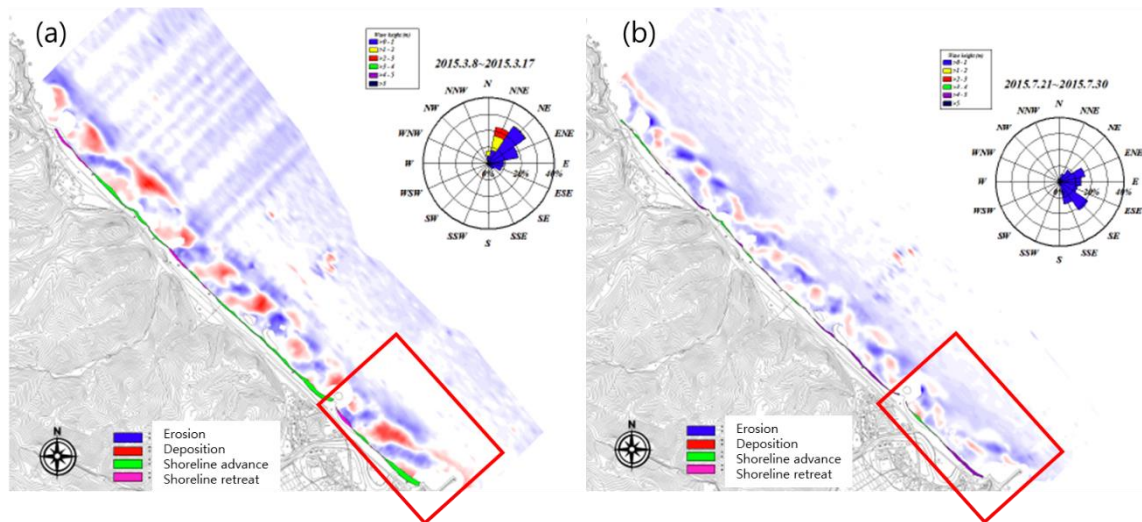
Figure 5 shows typical shoreline change patterns in winter and summer seasons in Jeongdongjin beach (red-colored boxes) based on the data collected in 2015. In Figure 5(a), dominant waves come to the beach in NE direction and the beach sand moved to the south in winter while dominant waves reach the beach in SE direction and the sediment moved the north in summer (Figure 5(b)). Also, the figure shows the crescentic sand bar formation and movement in different season due to the different incident wave conditions.

Figure 5. Incident wave conditions by using AWAC in winter (left) and summer (right) seasons. Top panels, middle panels, and bottom panels indicate the significant wave heights, significant wave periods, and mean wave directions respectively.

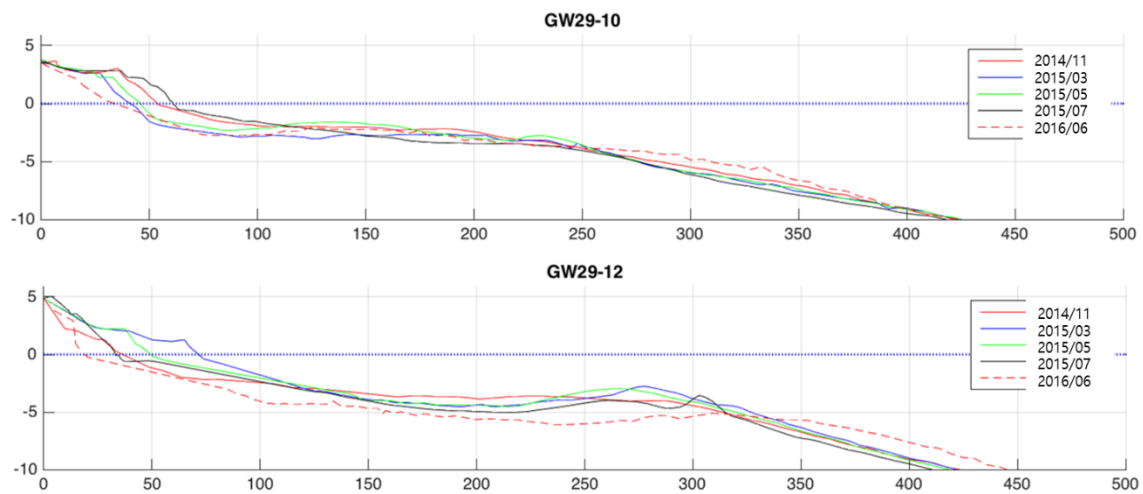
Figure 7 also shows the temporal variation of the beach profile of GW29-10 and GW29-12 in cross-shore direction. In this figure, it is found that longshore sediment transport is dominant compared to the cross-shore sediment transport because the beach profile change near the swash zone is much larger than the profile change near the offshore sand bar. Therefore, the beach sands near the swash zone mostly move to north and south along the shoreline.

Figure 7. Temporal variation of the beach profile of GW29-10 and GW29-12.
