WAVE PROCESSES AND OVERWASH HAZARD ON A HIGH-ENERGY ROCK PLATFORM

Michael A. Kinsela¹, Hannah E. Power², Caio E. Stringari², Murray Kendall², Bradley D. Morris¹ and David J. Hanslow¹

Abstract

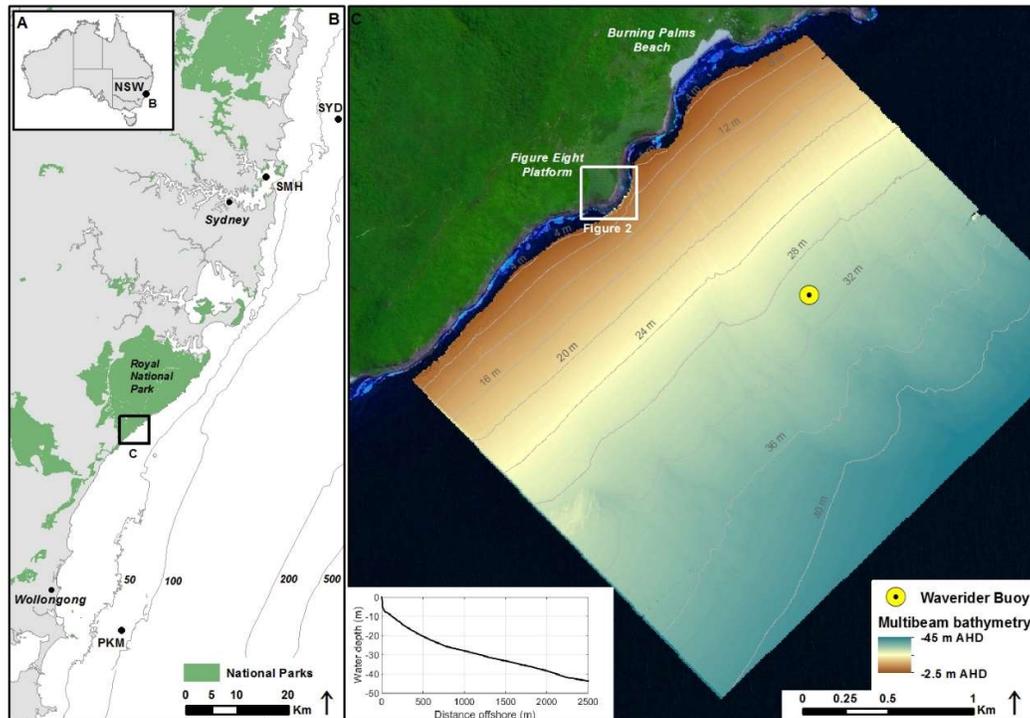
Figure 1. The Figure Eight rock platform is located in the Royal National Park about 50 km south of Sydney, Australia. The coastline trends northeast-southwest and is fully exposed to waves arriving from the northeast to south directions.

Directional waverider buoys are maintained at Sydney (SYD) and Port Kembla (PKM), and an ocean tide gauge at Middle Head in Port Jackson (SMH). A directional waverider buoy was deployed in 30 m water depth adjacent to the Figure Eight rock platform to measure local wave conditions. The bathymetry profile runs SE out from the platform.

The Figure Eight rock platform is a high visitation and hazardous natural attraction located in the Royal National Park, about 1 hour south of Sydney, Australia (Figure 1). The site features a variety of unique natural rock pools, including the namesake Figure Eight Rock Pool, which have been weathered into the sandstone platform over thousands of years. Despite challenging access via a steep escarpment trail and rocky shore traverse (minimum 2 hours return walk), the rock pools attract a high volume of local and international visitors, who primarily visit to bathe in the pools and have their photo taken. The hazardous setting, unique morphology and high visitation present challenges to managing visitor safety at the site.

Permanent deep-water waverider buoy deployments are maintained in about 80 m water depth off the coasts of Sydney and Port Kembla (Figure 1B). The Sydney wave buoy has collected directional wave data since 1992, while the Port Kembla buoy was upgraded to a directional instrument in 2013 (non-directional wave measurement extends back to the mid-1970s in both areas). The most reliable ocean tide gauge in the region is the Sydney Middle Head tide gauge located directly inside the entrance to Port Jackson (Figure 1B).

A Datawell DWR-G4 waverider buoy was deployed in 30 m water depth adjacent to the Figure Eight rock platform (Figure 1C) to measure local wave conditions throughout the period of camera monitoring and hydrodynamic measurements. The buoy was first deployed on 6 December 2016 and is serviced every 5 weeks to de-foul the hull, replace the batteries and retrieve the data. The deployment is ongoing.

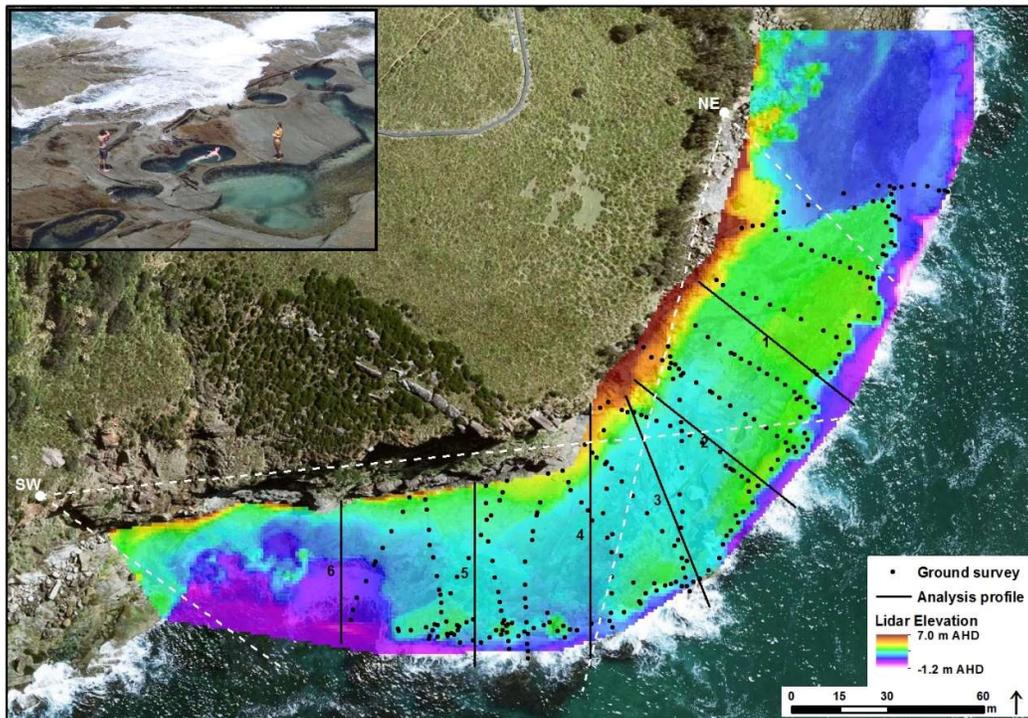
Figure 2. Morphology of the Figure Eight rock platform as captured by airborne Lidar data. See Figure 1C for location. The northeast (NE) and southwest (SW) camera positions and fields of view are indicated in white, and the camera image analysis profiles and ground topography survey points are also shown. Inset shows typical visitor behaviour.

The Figure Eight rock platform is a relatively flat and wide intertidal to supratidal sandstone platform with a curved northeast-southwest orientation that fringes coastal cliffs of 40 m elevation (Figure 2). The platform extends 50 m on average from the base of the cliffs to the shore, where it drops abruptly into the sea. The seaward edge of the platform is near-vertical and well defined in the vicinity of the mean sea-level shoreline, reflecting the 'type-B' platform (Sunamura, 1992; Kennedy, 2015). The water depth at the seaward edge is around 5 m, and the nearshore seabed slopes steeply to around 7-8 m. The inner-continental shelf fronting the platform has an average slope of 1:50 out to 50 m water depth (Figure 1C), and an inner-shelf sand body has been reported along this coastal sector (Field and Roy, 1984). The escarpment, cliffs and rock platform form part of the East Australian marine abrasion surface, formed of Mesozoic-Palaeozoic sedimentary rocks cut and planed by cyclic marine erosion, which extends 300 km along the coast north and south of Sydney and up to 23 km offshore (180 m below sea level) beneath continental shelf sediments (Thom et al., 2010).

The topography of the platform is complex, with the northeast section higher than the southwest section, and the seaward edge often higher than the mid-platform elevation (Figure 2). While platform elevation is generally above the highest astronomical tide – around 1 m above Australian Height Datum (AHD), which approximates mean sea level – in this microtidal setting (2 m maximum tidal range), the platform is exposed to the full range of wave directions (northeast to south) within a moderate-high energy wave climate (mean $H_{sig}=1.6$ m, $T_{sig}=8$ s). The irregular elevation and form of the seaward edge exposes the platform to overwash and inundation caused by waves predominantly arriving from south to southeast directions.

The topography of the rock platform was captured in an airborne Lidar survey carried out by New South Wales Land and Property Information (LPI) in 2013, which is presented as a 1 m grid in Figure 2 (horizontal accuracy 0.8 m, vertical accuracy 0.3 m – 95% CI). Considering the complex morphology of the site, a ground topography survey was carried out using a Leica real-time kinematic GNSS system to ground-truth the 1 m gridded Lidar data. The sampling pattern for the ground survey is shown in Figure 2.

A coastal camera monitoring system was installed at the site to collect a dataset of platform hydrodynamic conditions for the range of tide and wave conditions experienced during the sampling period. The cameras were installed in March 2017 and monitoring will continue for a minimum period of 3 months. Considering platform curvature and the high coastal cliffs, cameras were installed in two locations in elevated positions to capture the primary area of interest for observing wave overwash processes (Figure 2).

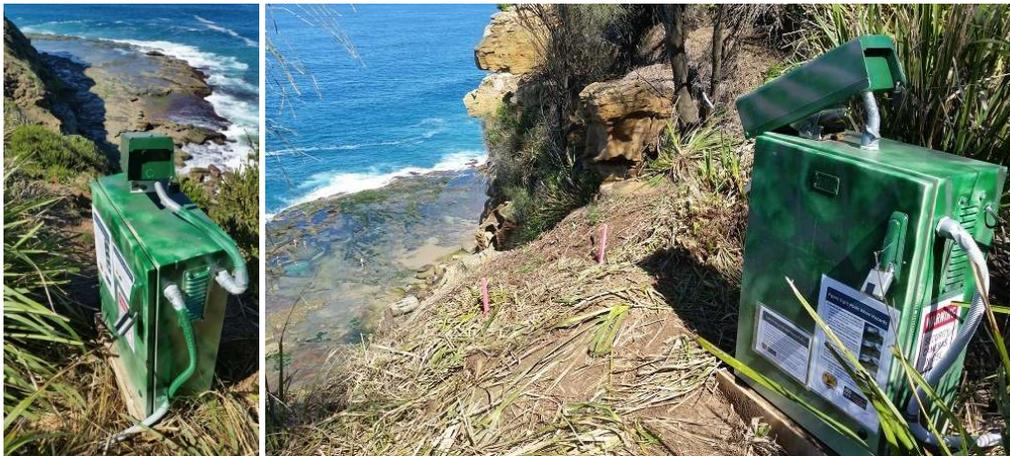
Figure 3. Photos of the southwest (left) and northeast (right) camera system installations. See Figure 2 for locations.

The camera systems comprised 3.2 megapixel Point Grey Flea3 colour image cameras fitted with Fujinon 6 mm lenses. Solar-battery power supply systems were installed at both sites to provide sufficient power under the range of potential weather conditions. The cameras are operated automatically by Raspberry Pi computers that store the image data on USB flash drives. Mobile telephone network modems were also fitted to telemeter sample images and system information at each capture cycle for monitoring. The computers were configured to capture images at 1 Hz for 20 minutes from the beginning of each daylight hour.

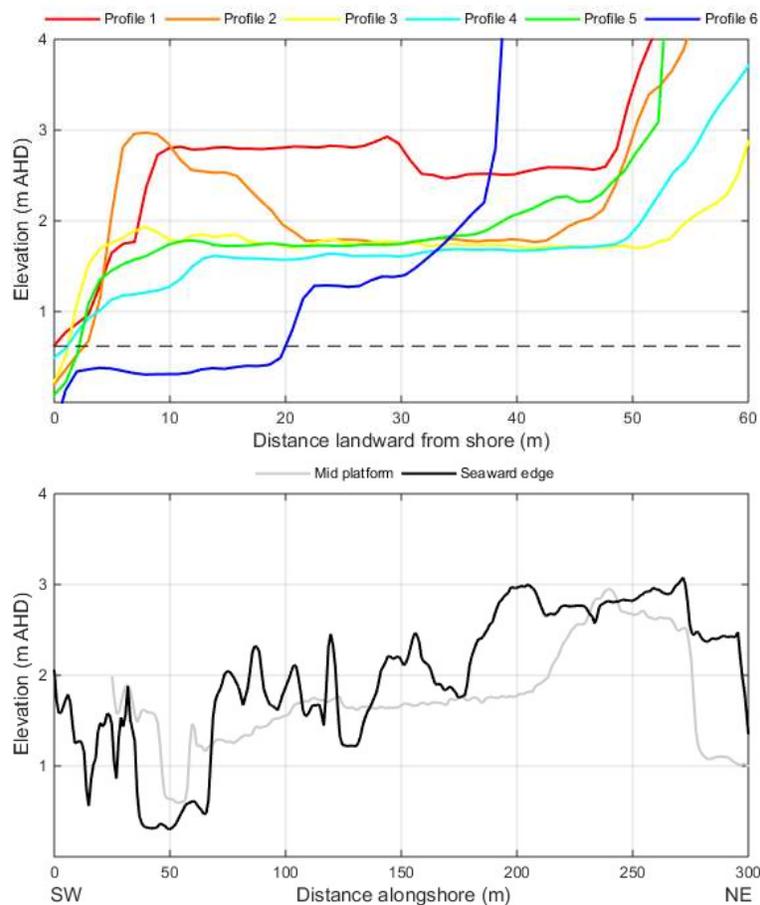
Figure 4. Lidar-derived terrain profiles for the six image analysis profiles shown in Figure 2 (top), and alongshore terrain profiles taken along the middle and seaward edge of the platform (bottom). Dashed line is mean high water.

Figure 4 shows Lidar-derived terrain profiles for the six cross-shore image analysis profiles (Figure 2), and alongshore terrain profiles taken along the middle and seaward edge of the platform. The topography of the seaward edge varies along the platform. The southwest (SW) half of the platform features a lower seaward edge of highly variable elevation between 1-2 m AHD. The northeast (NE) half of the platform features a more consistent higher seaward edge between 2-3 m AHD elevation. Landward of the seaward edge platform elevation is typically at or below the seaward edge. Of particular interest, Profile 2, which intersects the namesake Figure Eight rock pool, features a seaward edge around 1 m higher than the mid-platform elevation.

With the exception of the sector in the vicinity of Profile 6, platform elevation is typically above the still-water mean spring high tide and highest astronomical tide levels (Figure 4). This is reflected in Figure 2 as platform surfaces that are shaded light blue, green, or warmer colours.

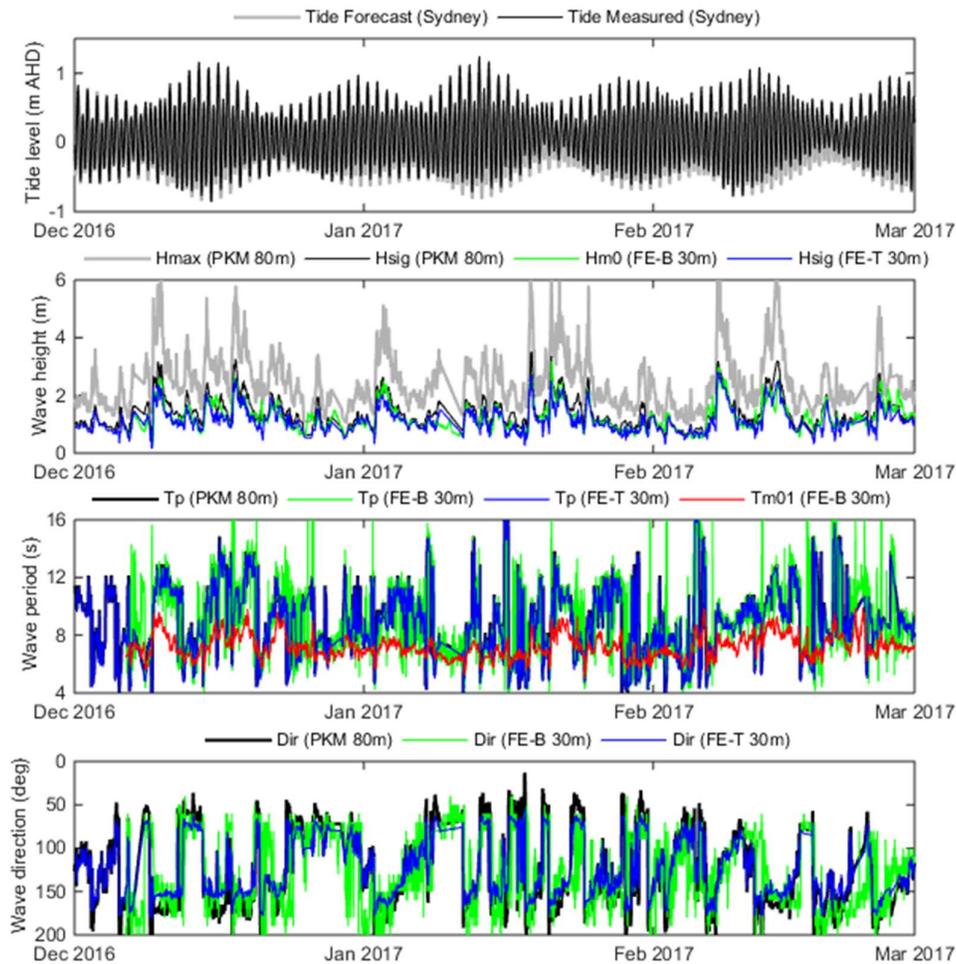
Figure 5. Ocean tide (Sydney), offshore waves (Port Kembla: PKM), measured nearshore waves (Figure Eight: FE-B) and transformed nearshore waves (Figure Eight: FE-T) for 12/2016 to 3/2017. See Figure 1 for station locations.

Figure 5 shows offshore and nearshore wave data from the study area for the period December 2016 to March 2017, including the first 3 months of the wave buoy deployment adjacent to the Figure Eight rock platform (Figure 1). Visual comparison between the offshore observations at the Port Kembla 80 m buoy (black), and at the Figure Eight 30 m buoy (green), suggest that nearshore wave heights are slightly lower than offshore, while wave period and direction appear comparable between the stations.

Figure 5 also suggests that transformed wave predictions from the NWTT (blue) provide a good predictor of measured wave conditions at the Figure Eight 30 m buoy location (green). Figure 6 (right) compares the transformed wave height from the NWTT with measured wave height at the Figure Eight 30 m buoy, for the 3-month period shown in Figure 5. The root-mean-square error and bias are 0.26 and -0.085 respectively.

Inspection of the tide and wave data shown in Figure 5 suggests that a wide range of conditions have been sampled at the Figure Eight 30 m buoy location. Figure 7 shows wave height-direction polar plots based on 4 years of directional observations at the Port Kembla 80 m buoy, and 4 months of observations at the Figure Eight 30 m buoy. The comparison indicates a relatively consistent sampling of ENE, ESE and SE wave directions at the Figure Eight 30 m buoy during that period, with the highest wave conditions arriving from the predominant ESE and SE directions. The comparison also confirms that the Figure Eight rock platform is exposed to the full range of wave directions experienced in this region.

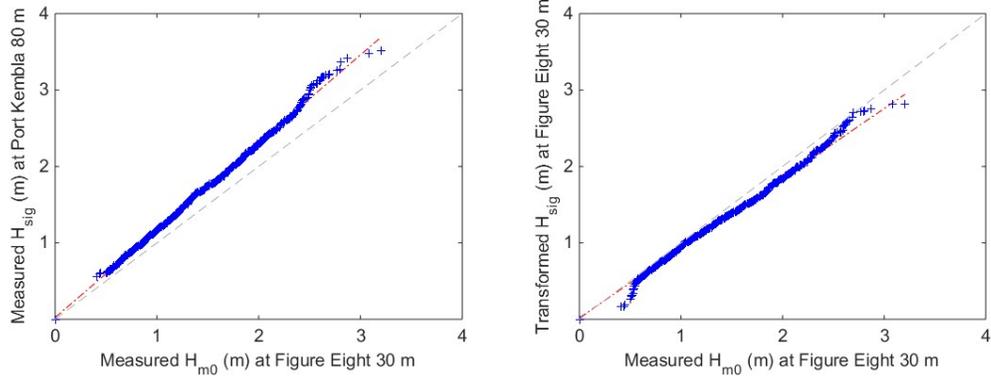
Figure 6. Quantile-quantile plots comparing significant wave height measured at the Port Kembla 80 m wave buoy and Figure Eight 30 m wave buoy (left), and comparing transformed (NWTT) and measured significant wave height at the Figure Eight 30 m wave buoy location (right), for the 3-month period shown in Figure 5.

At the Figure Eight wave buoy, measured significant wave height (H_{m0}) exceeded 2 m for 17% of the total buoy deployment period to date (6/12/2016-27/3/2017), and exceeded 3 m for 2.5% of the time. Figure 6 (left) compares significant wave height measured at the Port Kembla 80 m buoy and at the Figure Eight 30 m buoy for the period shown in Figure 5. The comparison shows that wave height attenuation from the mid to inner shelf increases with increasing wave height. The Port Kembla wave buoy was out of service during March 2017 and so Figure 5 and Figure 6 only show wave data for the period 6/12/2016-1/3/2017.

The wave climate analysis confirmed that the Figure Eight rock platform is exposed to the full spectrum of wave directions (northeast to south) experienced in this region (Figure 7), and that wave height attenuation from the mid to inner shelf increases with increasing wave height (Figure 6). Furthermore, the transformed significant wave height predicted by the NSW Nearshore Wave Transformation Tool at the Figure Eight 30 m buoy location compared well with measured wave heights (Figure 6). This suggests that once the combined ocean tide and relative wave run-up thresholds for overwashing have been refined and verified at Figure Eight rock platform using the camera monitoring data, measured and projected ocean tide data and the wave transformation tool may be used to provide real-time and forecast overwash hazard advice, based on real-time offshore wave buoy data and a deep-water ocean wave forecast.

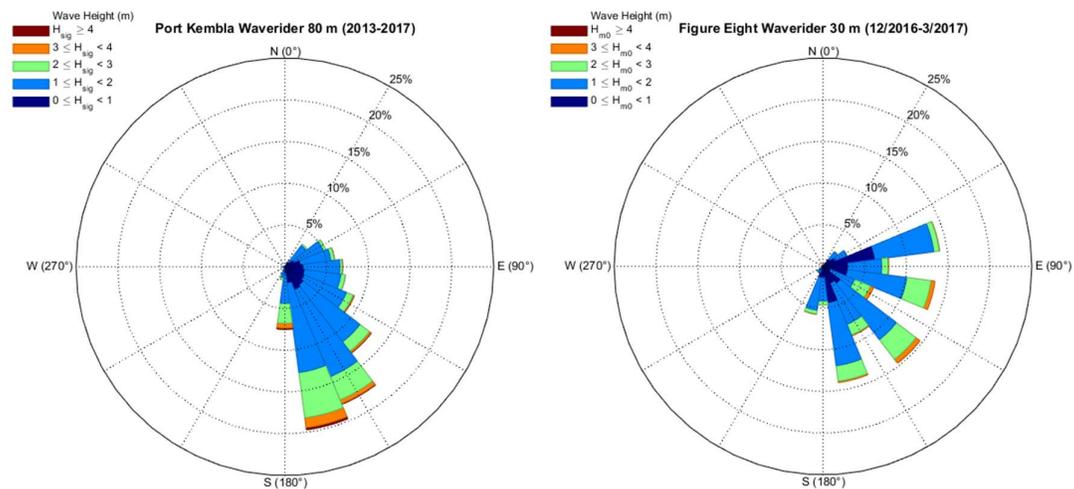
Figure 7. Wave height-direction polar plots for data from the Port Kembla 80 m wave buoy (2013-2017) and the Figure Eight 30 m wave buoy (6/12/2016-27/3/2017) deployments. See Figure 1 for station locations. Credit: WindRose.m.

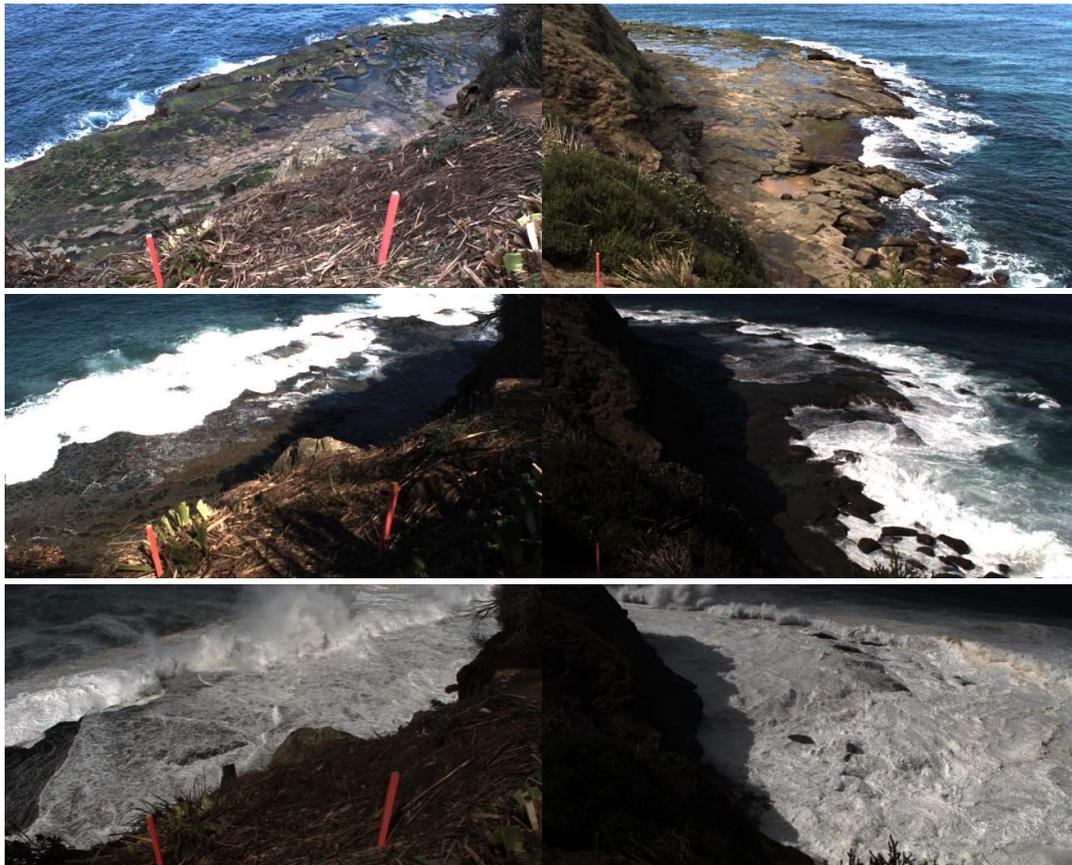
Figure 8. Camera monitoring images showing: no overwashing (top), partial-intermittent overwashing (middle) and complete inundation (bottom) conditions at Figure Eight rock platform. Images from the northeast (left) and southwest (right) cameras (Figure 2) were captured simultaneously and together show the platform in view under each condition.

As anticipated from the consideration of platform morphology and regional wave and tide data, preliminary analysis of the camera image data confirms that the Figure Eight rock platform is subject to the full spectrum of potential hydrodynamic conditions, which are categorised here as: (1) no overwashing; (2) partial-intermittent overwashing; and, (3) complete inundation. Figure 8 shows examples of each of the three hydrodynamic conditions as captured by the camera monitoring systems. The three conditions can be differentiated on the basis of the frequency, duration and extent of wave overwashing across the platform.

of ordinary wave conditions (Figure 8): (1) no overwashing; (2) partial-intermittent overwashing; and, (3) complete inundation. Second, both alongshore and cross-shore variability in platform morphology (Figures 2 & 4) suggest that the nature of partial-intermittent overwashing conditions may vary depending on the combined ocean tide and wave water level, and wave direction. Third, the highly variable morphology of the seaward edge (Figure 4) means that the frequency and intensity of overwashing may be unpredictable during partial-intermittent conditions, depending on how individual incident waves interact with the seaward edge. Lastly, the elevated seaward edge along the most visited part of the platform (Profile 2, Figure 4) means that visitor's views of the ocean and incident waves is restricted when bathing in the pools in that area.

In terms of managing visitor safety, partial-intermittent overwashing conditions present the greatest challenge. This is due to the complex and unpredictable nature of those conditions, as described above, and an apparent reduction in the perceived risk of wave overwash hazards. For example, comparison between emergency response data from 2016 and measured offshore wave conditions, indicates that the majority of major incidents occurred when offshore significant wave height was around 2 m (i.e. near modal conditions for this coast), which is associated with partial-intermittent overwashing (Figure 10). During these conditions, wave height is low enough for the danger of overwash to be less apparent than during frequent or complete inundation. The first-pass overwash hazard model based on the combined ocean tide and relative wave run-up level exceeded 2 m AHD – i.e. the average elevation of much of the platform (Figure 4) – for 66% of the initial 4 months of the Figure Eight 30 m wave buoy deployment, and exceeded 3 m AHD for only 30% of that same period (Table 1). During inundation conditions, when the wave run-up level constantly exceeds 3 m AHD, the platform is inaccessible due to continuous and complete overwashing (Figure 8).

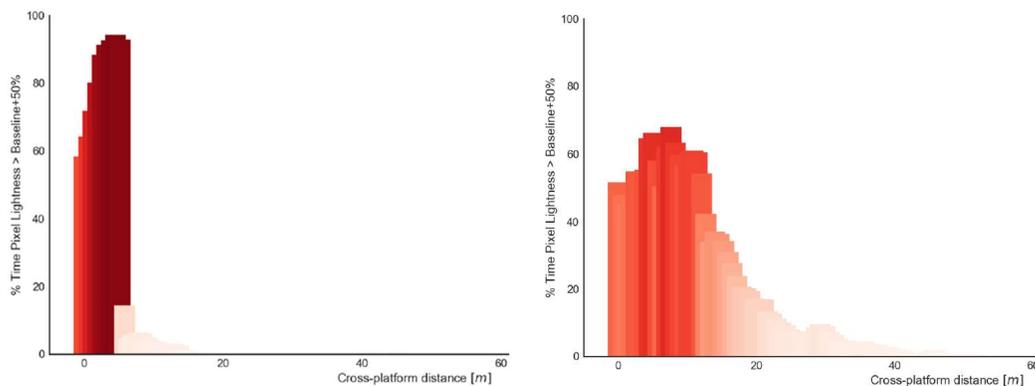
Figure 9. Example %-time-overwashing plots for partial-intermittent overwashing conditions featuring nuisance (left) and hazardous (right) overwashing. For the conditions on the left overwash is restricted to the vicinity of the seaward edge, while overwash waves frequently extend across the platform during the conditions on the right.

Figure 9 shows example %-time-overwashing (pixel lightness) plots for partial-intermittent overwashing conditions characterised as nuisance (left) and hazardous (right) overwashing. The plots show the proportion of time and extent of overwashing at profile 2 (Figure 2) during a 20-minute capture cycle. Threshold %-time-overwashing profiles will be derived from the full dataset to identify platform hydrodynamic conditions.

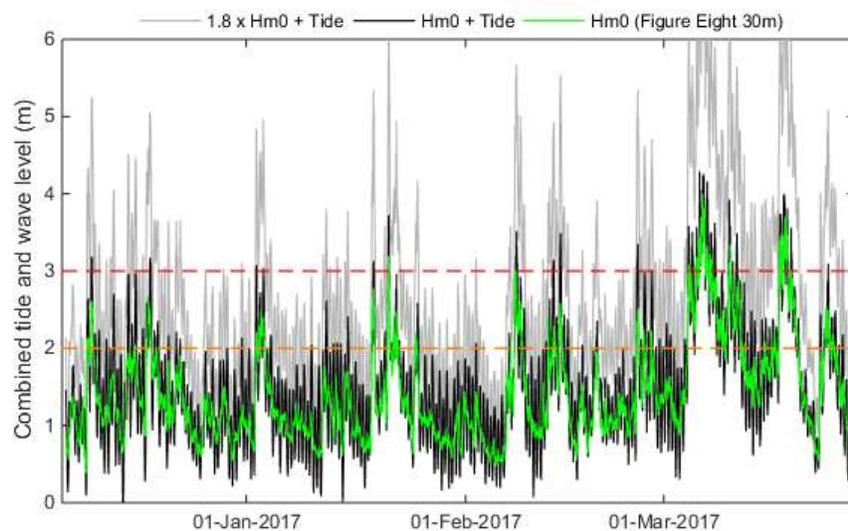
Figure 10. Significant wave height (H_{m0}) measured at the Figure Eight 30 m wave buoy (green), combined ocean tide and wave height water level (black), and combined ocean tide and relative wave run-up level ($R_{u2\%} = 1.8 \times H_{m0}$; grey). The orange and red lines indicate 2 m and 3 m AHD platform elevation thresholds (see Figure 4).

Figure 10 shows combined ocean tide and wave water levels for the first 4 months of the Figure Eight wave buoy deployment (6/12/2016-27/3/2017). The difference between the ocean tide and wave height level (black) and ocean tide and relative wave run-up level (grey) represents the influence of overwash processes predicted by the first-pass hazard model. The 2 m (orange) and 3 m AHD (red) platform elevation thresholds represent indicative platform overwash levels for profiles 3-5 and profiles 1-2 respectively (Figure 4).

The data shown in Figure 10 indicates that the combined ocean tide and wave height water level (black) was typically below the 2 m AHD platform elevation threshold, and only exceeded the 3 m AHD elevation threshold on several occasions during the 4-month period. Table 1 shows %-time-elevation exceedance values for the water and run-up levels shown in Figure 10 (Measured H_{m0}). While the combined ocean tide and wave height water level ($H_{m0} + \text{Tide}$) only exceeded the 2 m and 3 m AHD elevation thresholds 22% and 4.8% of the observation period, the ocean tide and relative wave run-up level ($1.8 \times H_{m0} + \text{Tide}$) exceeded the same elevation thresholds 66% and 30% of the time respectively.

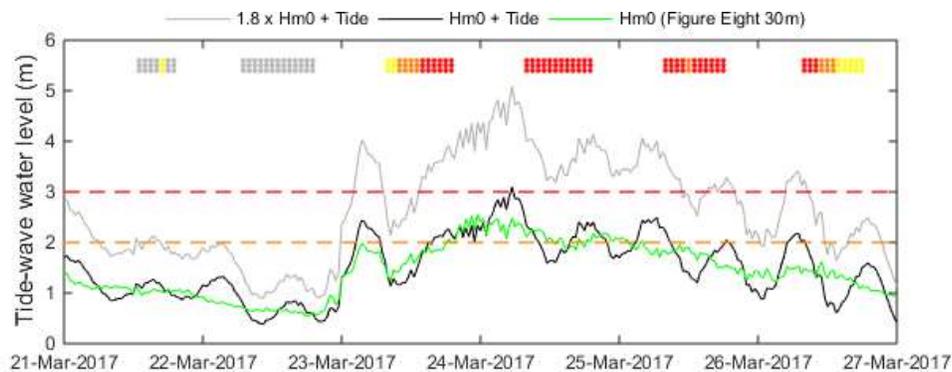
Figure 11. Combined ocean tide and wave water levels (see Figure 10 caption) covering the initial week of camera monitoring. Vertical colour bars at top indicate hydrodynamic conditions observed by the camera systems (see text).

The comparison in Figure 11 suggests that the first-pass overwash hazard model based on the ocean tide and relative wave run-up level (grey) provides a reasonable indicator of overwashing. For example, when below the 2 m AHD threshold platform overwashing was absent (grey) or nuisance (yellow), when between 2-3 m AHD overwashing was hazardous (orange), and when above 3 m AHD overwashing was extreme (red).
